STUDY REPORT

SR 241 (2011)

Corrosion of Fasteners in Treated Timber

BRANZ Study Report SR 241

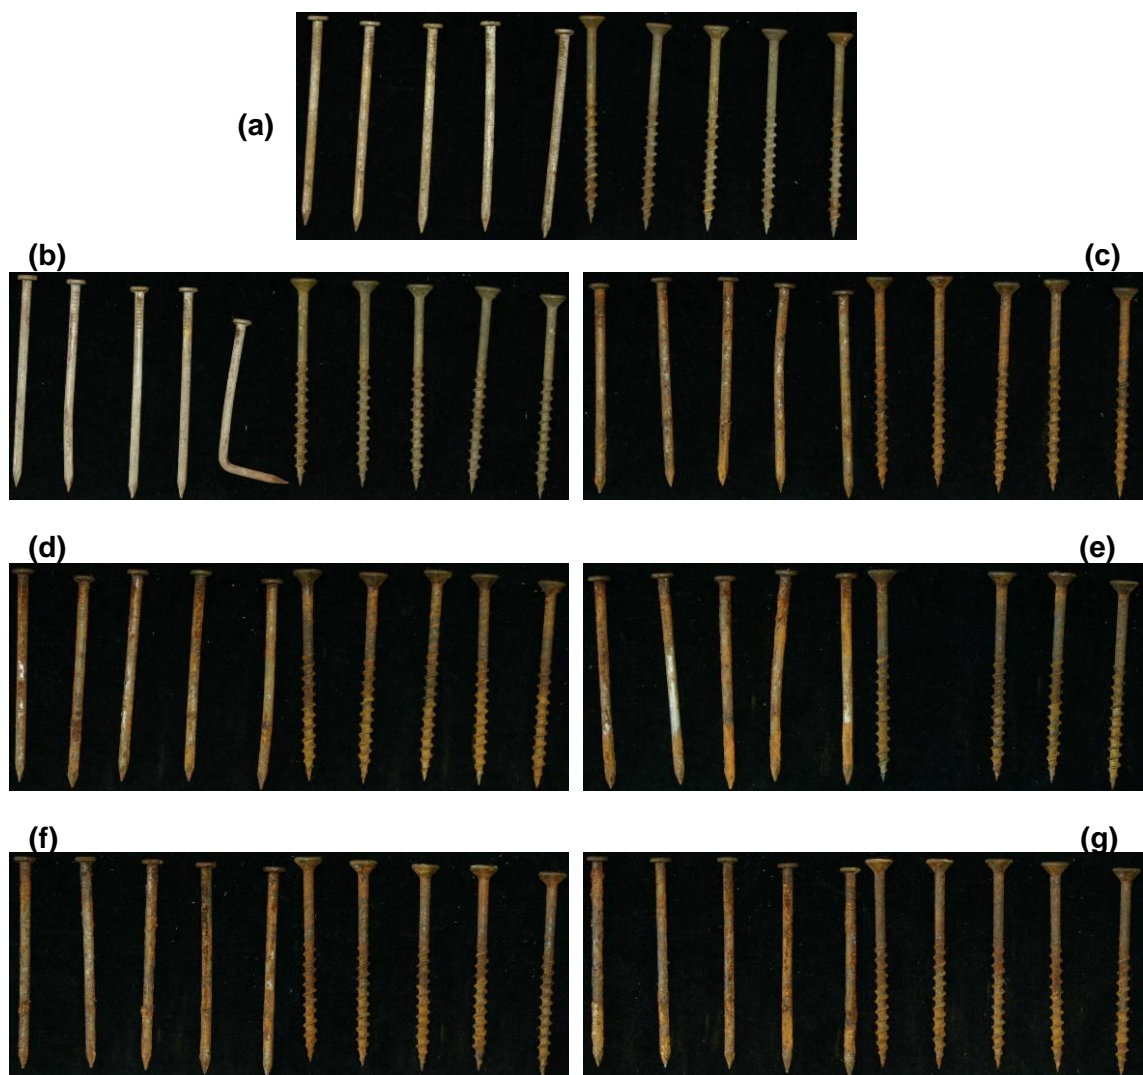
Figure 5: Surface morphology (before cleaning) of mild steel fasteners embedded into timbers exposed at Judgeford site for one year – (a) untreated, (b) H3 CCA, (c) H4 CCA, (d) H3 CuAz, (e) H4 CuAz, (f) H3 ACQ and (g) H4 ACQ

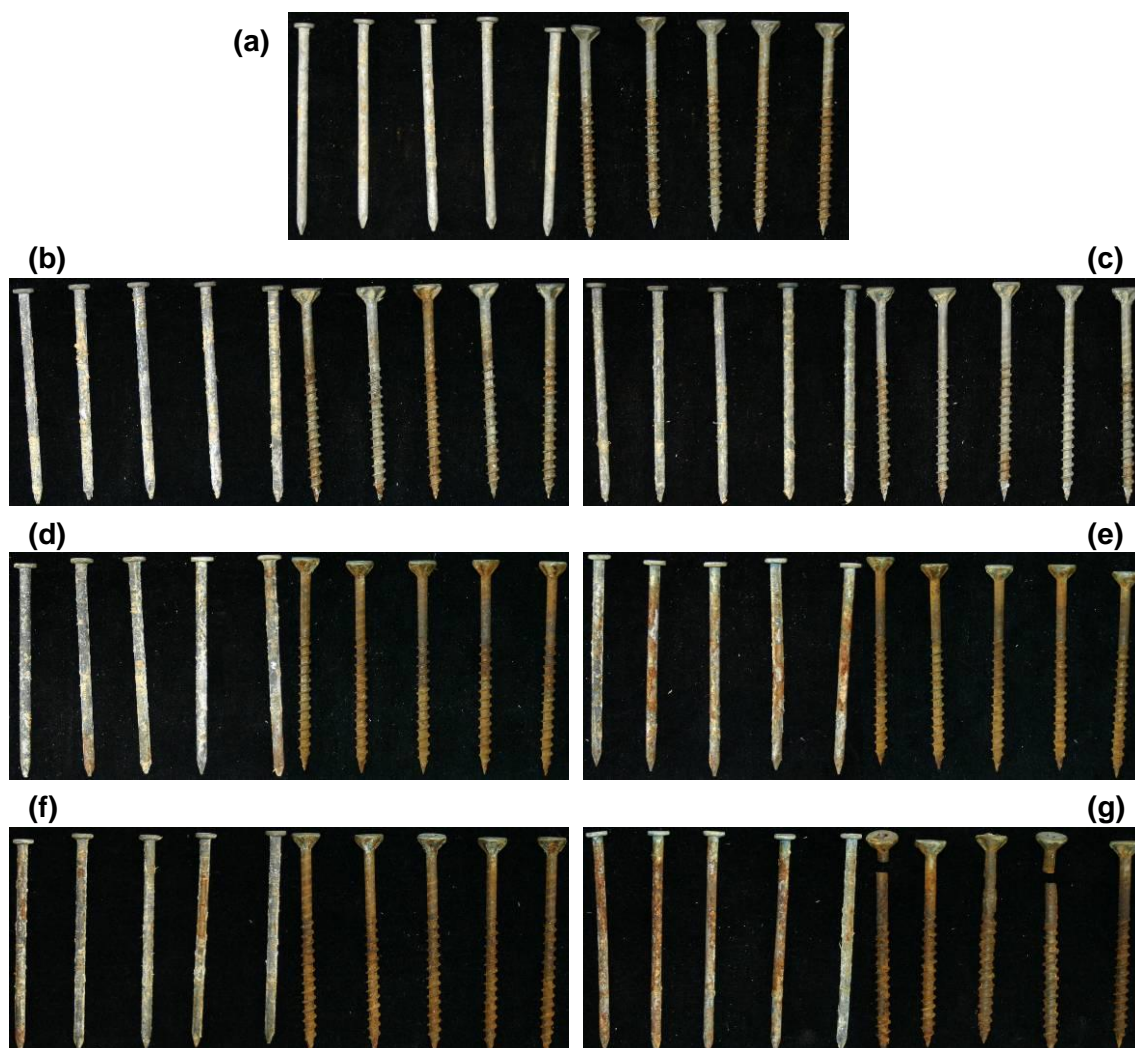
Figure 6: Surface morphology (before cleaning) of zinc-coated fasteners embedded into timbers exposed at Judgeford site for one year – (a) untreated, (b) H3 CCA, (c) H4 CCA, (d) H3 CuAz, (e) H4 CuAz, (f) H3 ACQ and (g) H4 ACQ

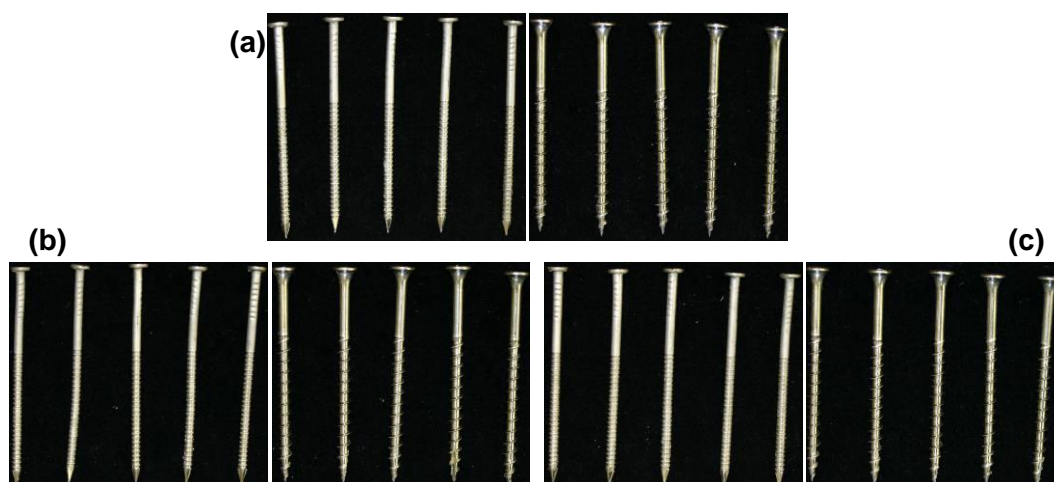
Figure 7: Surface morphology (before cleaning) of stainless steel fasteners embedded into timbers exposed at Judgeford site for one year – (a) H4 CCA, (b) H4 CuAz and (c) H4 ACQ

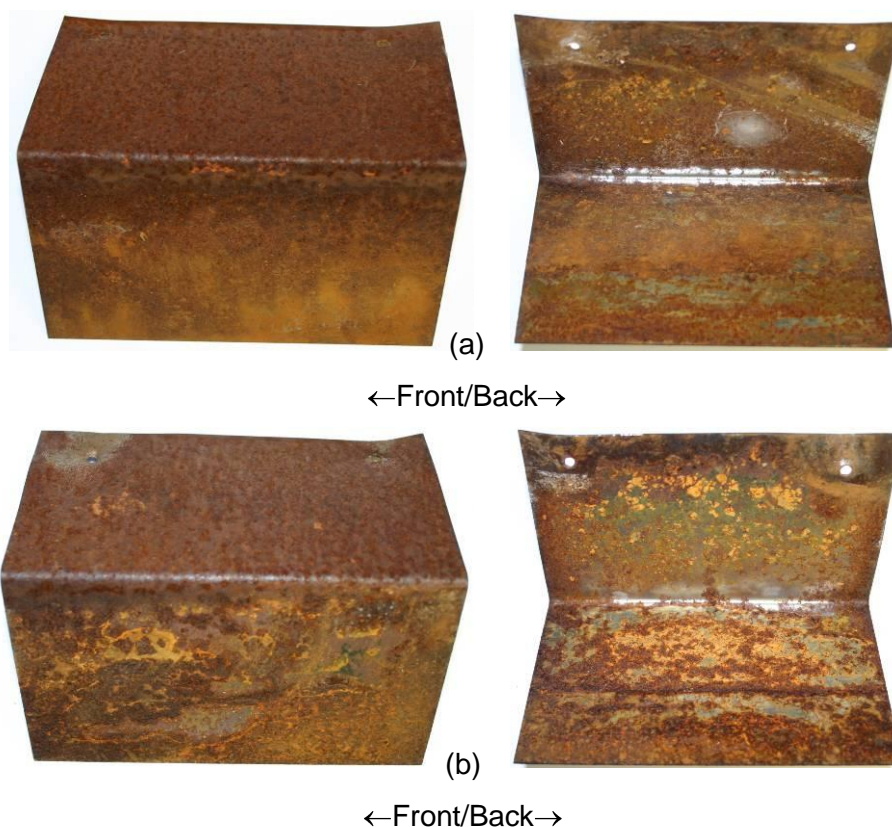
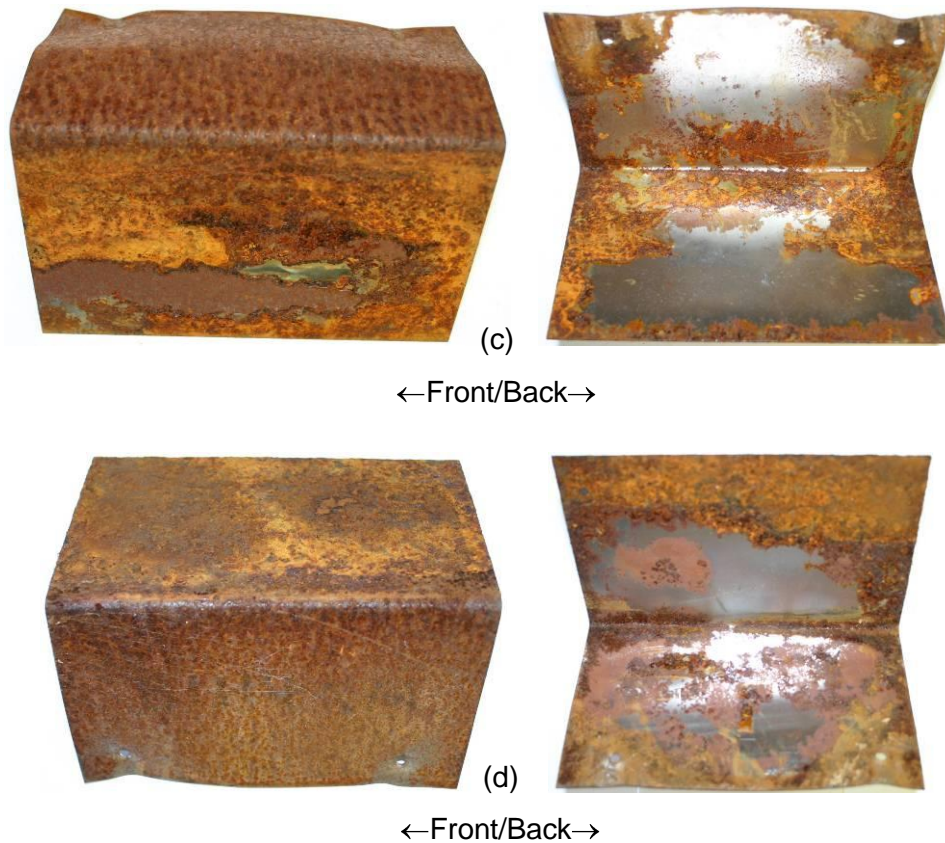
Figure 8: Surface morphology of mild steel flashing attached to timber exposed at Judgeford site for one year – (a) untreated, (b) H3 CCA, (c) H4 CuAz and (d) H4 ACQ

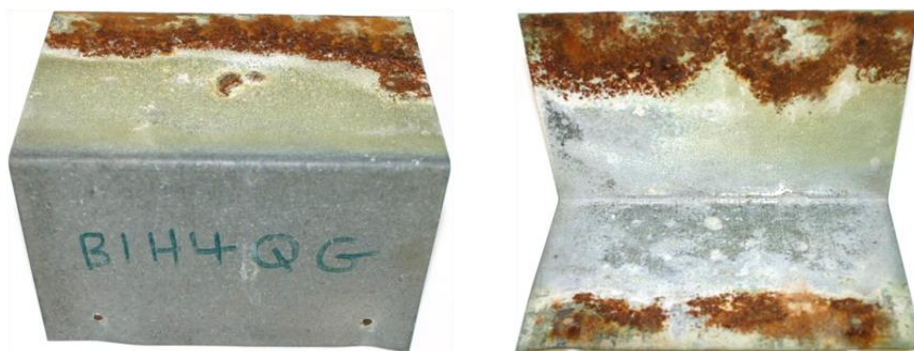
Figure 9: Surface morphology of hot dip galvanised steel flashing attached to timber exposed at Judgeford site for one year – the timber was treated with H4 ACQ

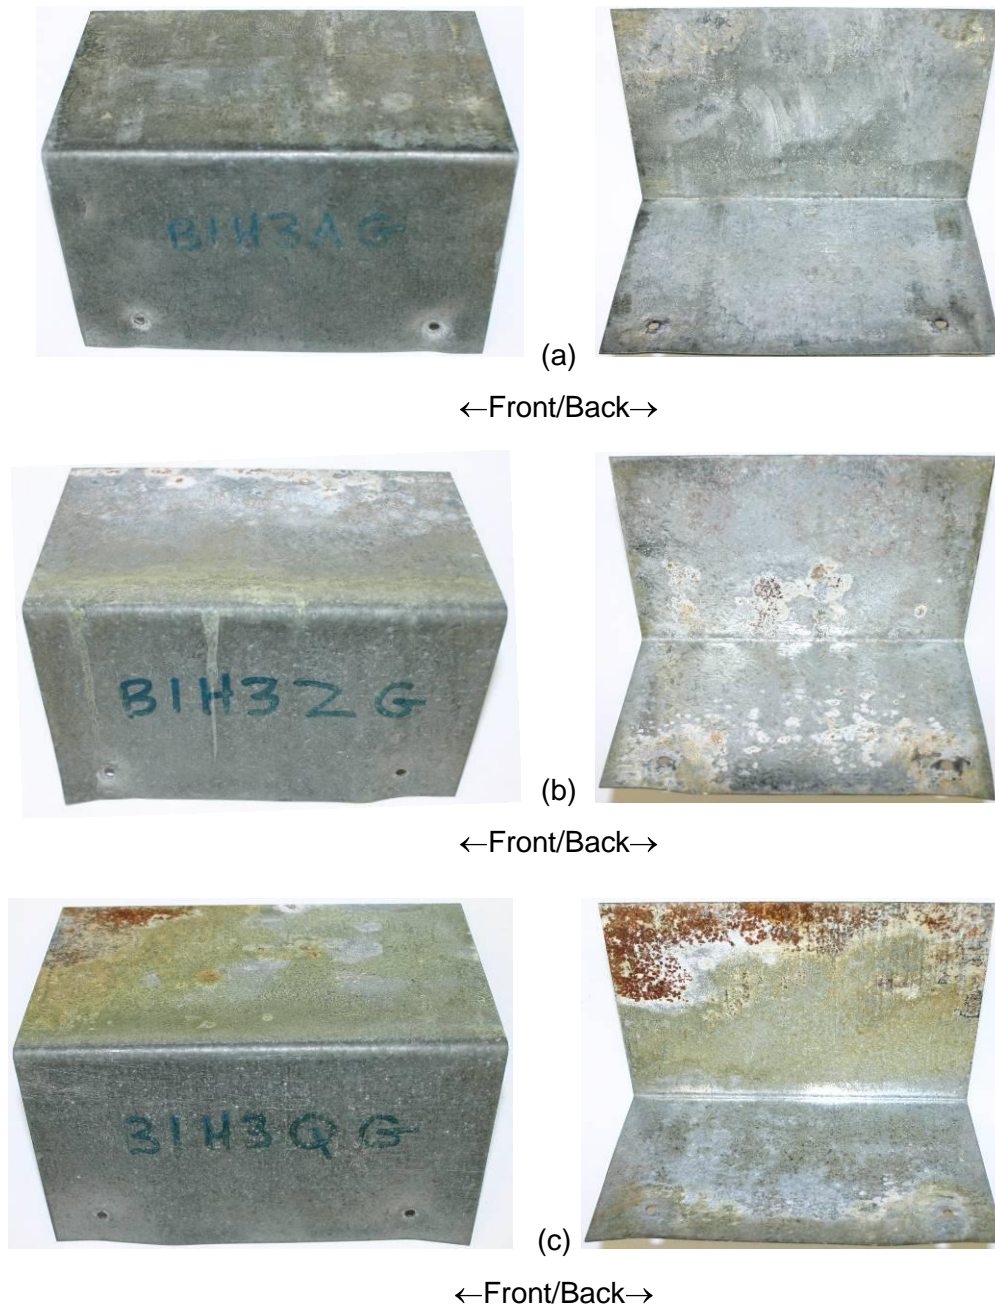
Figure 10: Surface morphology of hot dip galvanised steel flashing attached to timber exposed at Judgeford site for one year – (a) H3 CCA, (b) H3 CuAz and (c) H3 ACQ

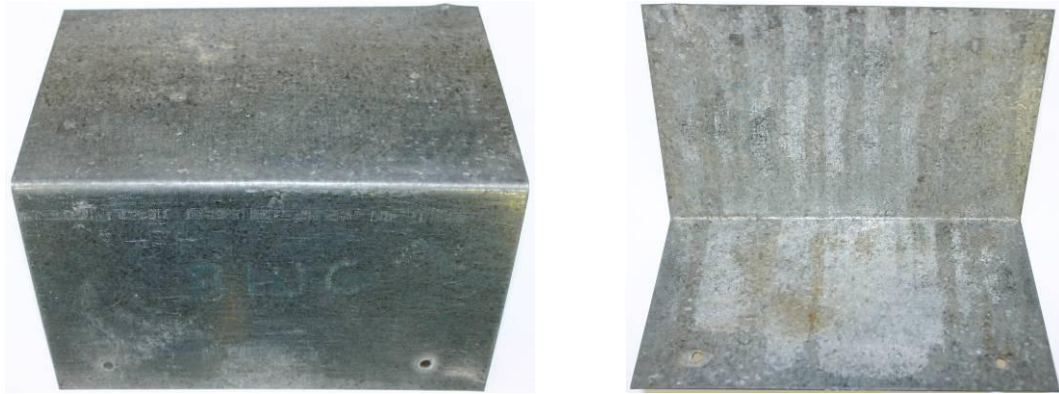
Figure 11: Surface morphology of hot dip galvanised steel flashing attached to untreated timber exposed at Judgeford site for one year

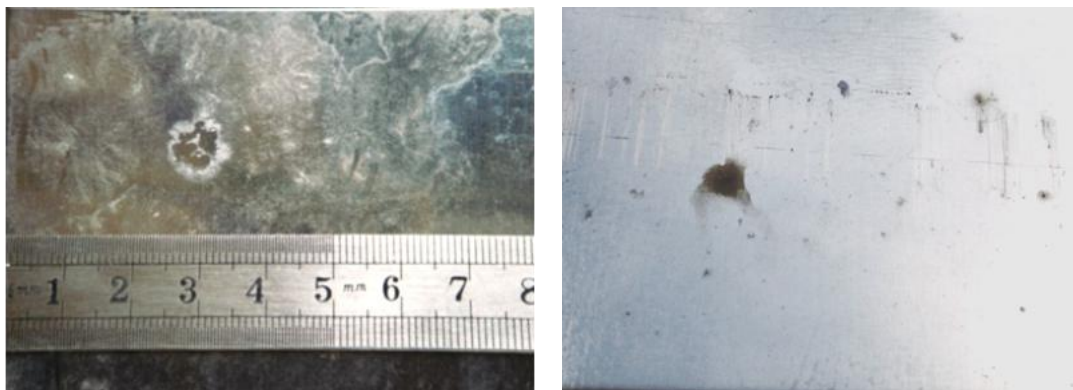
Figure 12: Stained (left) and scratch-corroded (right) areas observed on stainless steel flashings attached to H4 CuAz treated timbers and atmospherically exposed at Judgeford site for one year

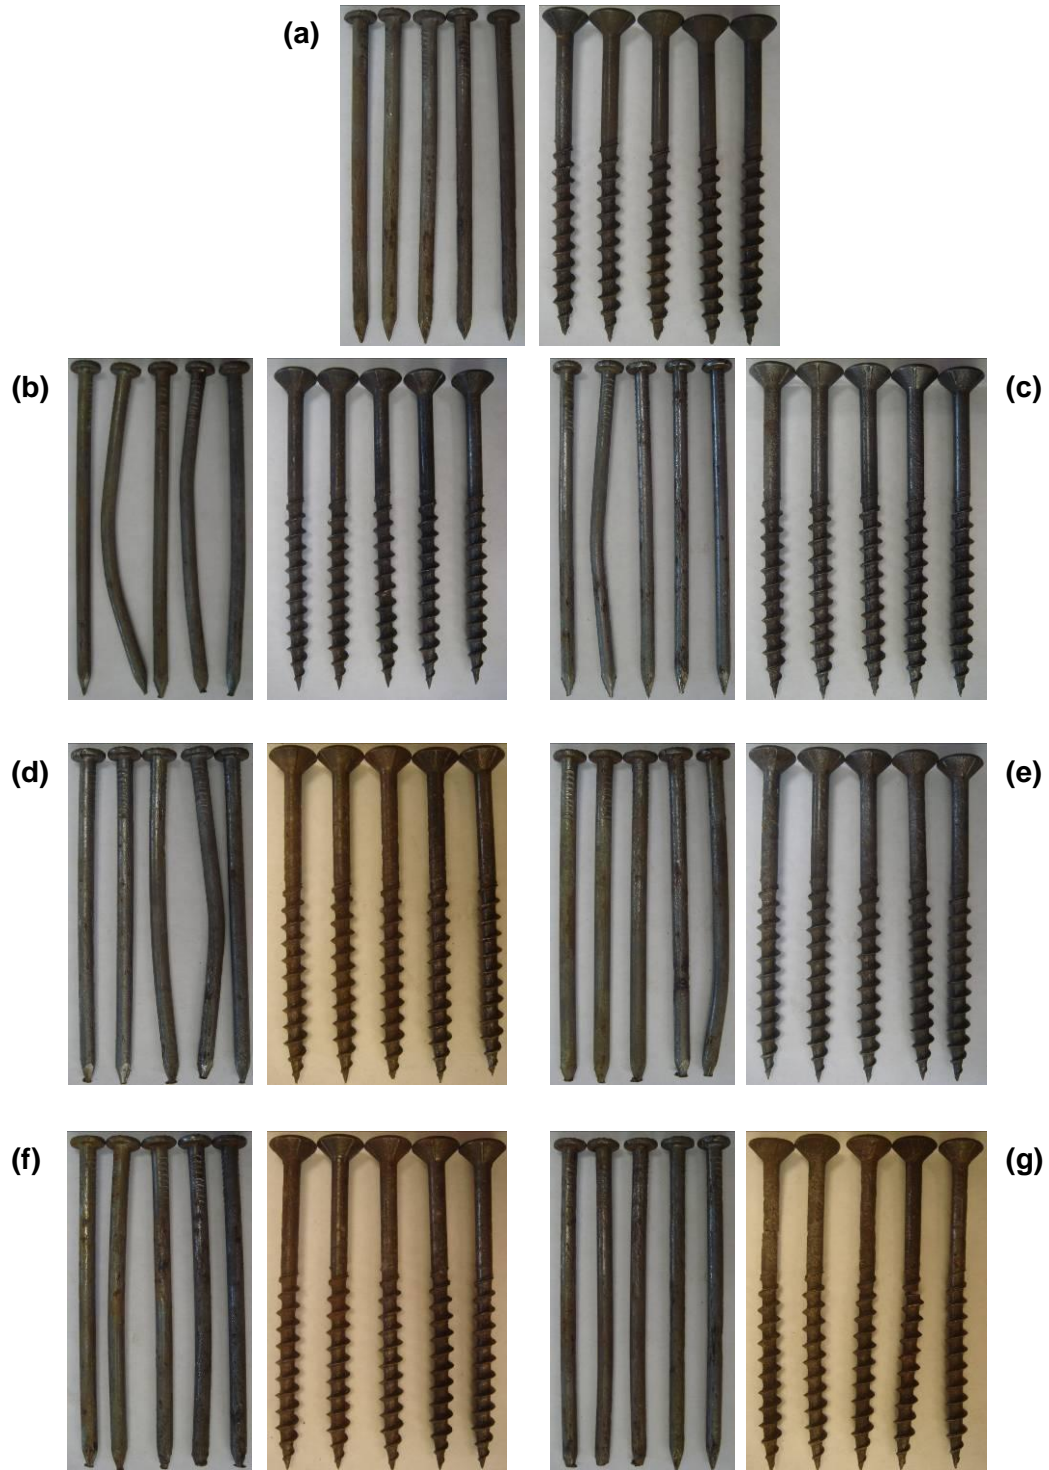
Figure 16: Surface morphology (after cleaning) of mild steel fasteners retrieved from timbers exposed at Judgeford site for two years (these fasteners were inserted into the timber blocks fixed at the lower (side) part of the gate structure and their longitudinal orientation was parallel to the ground) – (a) untreated, (b) H3 CCA, (c) H4 CCA, (d) H3 CuAz, (e) H4 CuAz, (f) H3 ACQ and (g) H4 ACQ

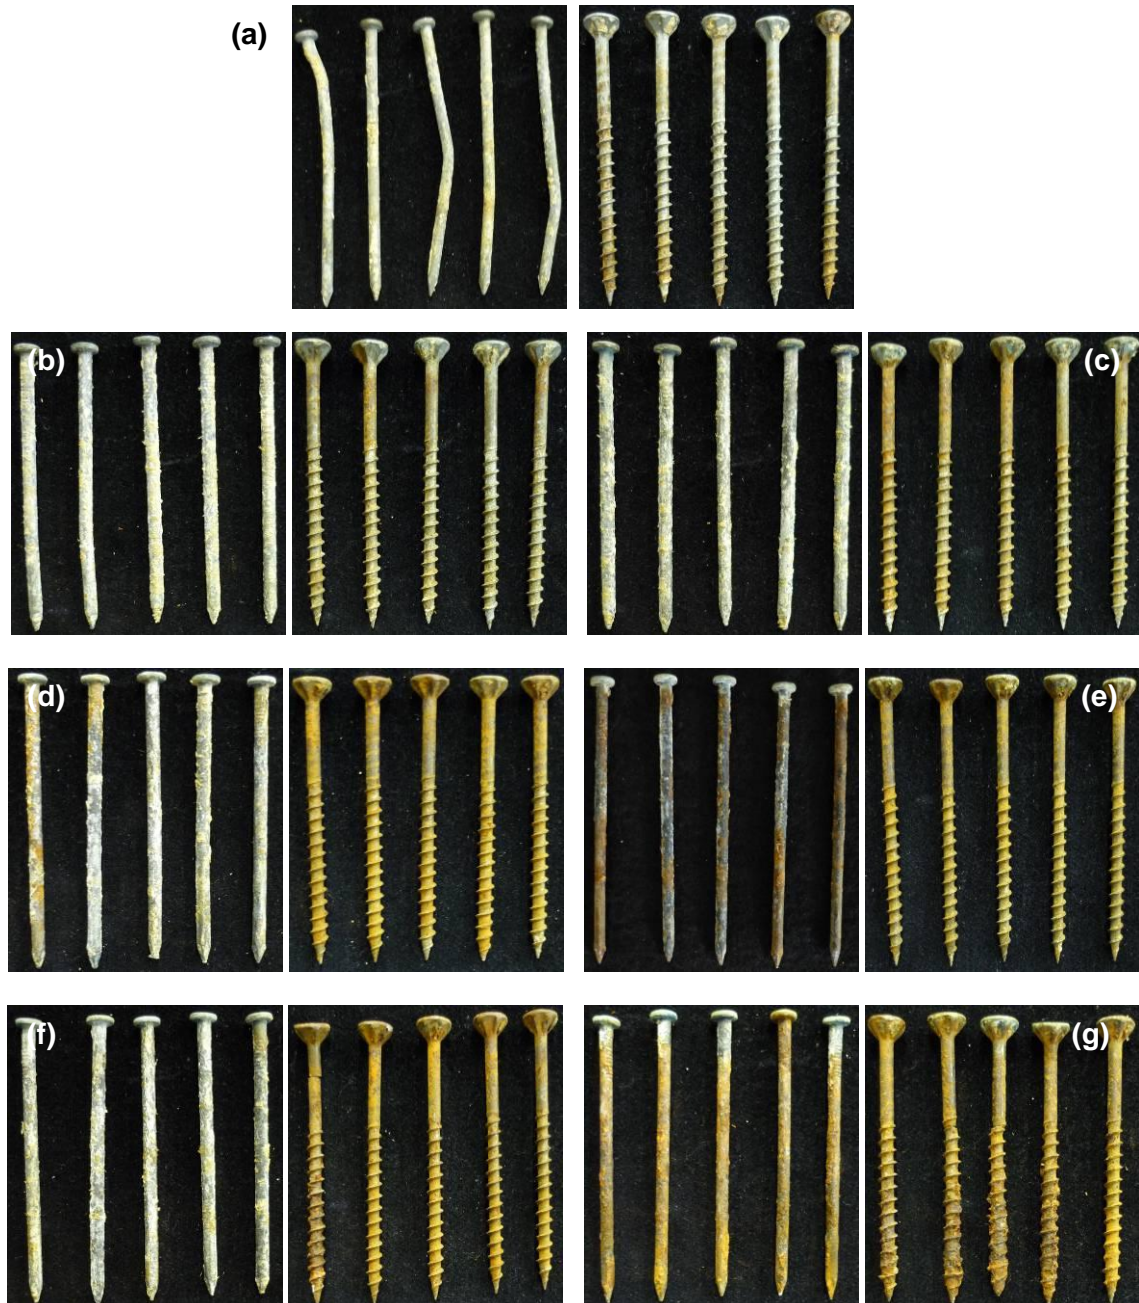
Figure 17: Surface morphology of zinc-coated fasteners retrieved from timbers exposed at Judgeford site for two years (these fasteners were inserted into the timber blocks fixed at the lower (side) part of the gate structure and their longitudinal orientation was parallel to the ground) – (a) untreated, (b) H3 CCA, (c) H4 CCA, (d) H3 CuAz, (e) H4 CuAz, (f) H3 ACQ and (g) H4 ACQ

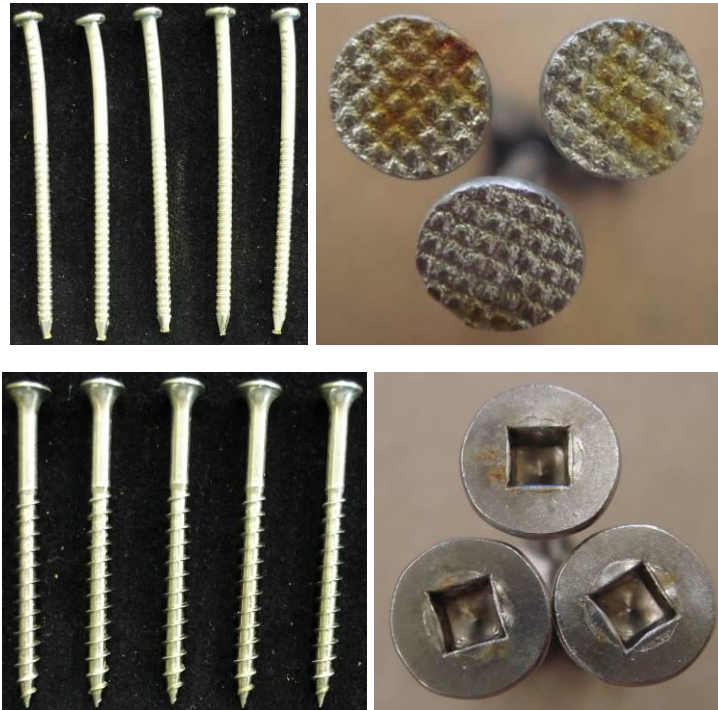
Figure 18: Typical surface morphology of stainless steel fasteners retrieved from H4 ACQ treated timbers exposed at Judgeford site for two years (these fasteners were inserted into the timber blocks fixed at the lower (side) part of the gate structure and their longitudinal orientation was parallel to the ground). Very limited iron-rich rust was occasionally found on the head top surface and the body section is free of damage

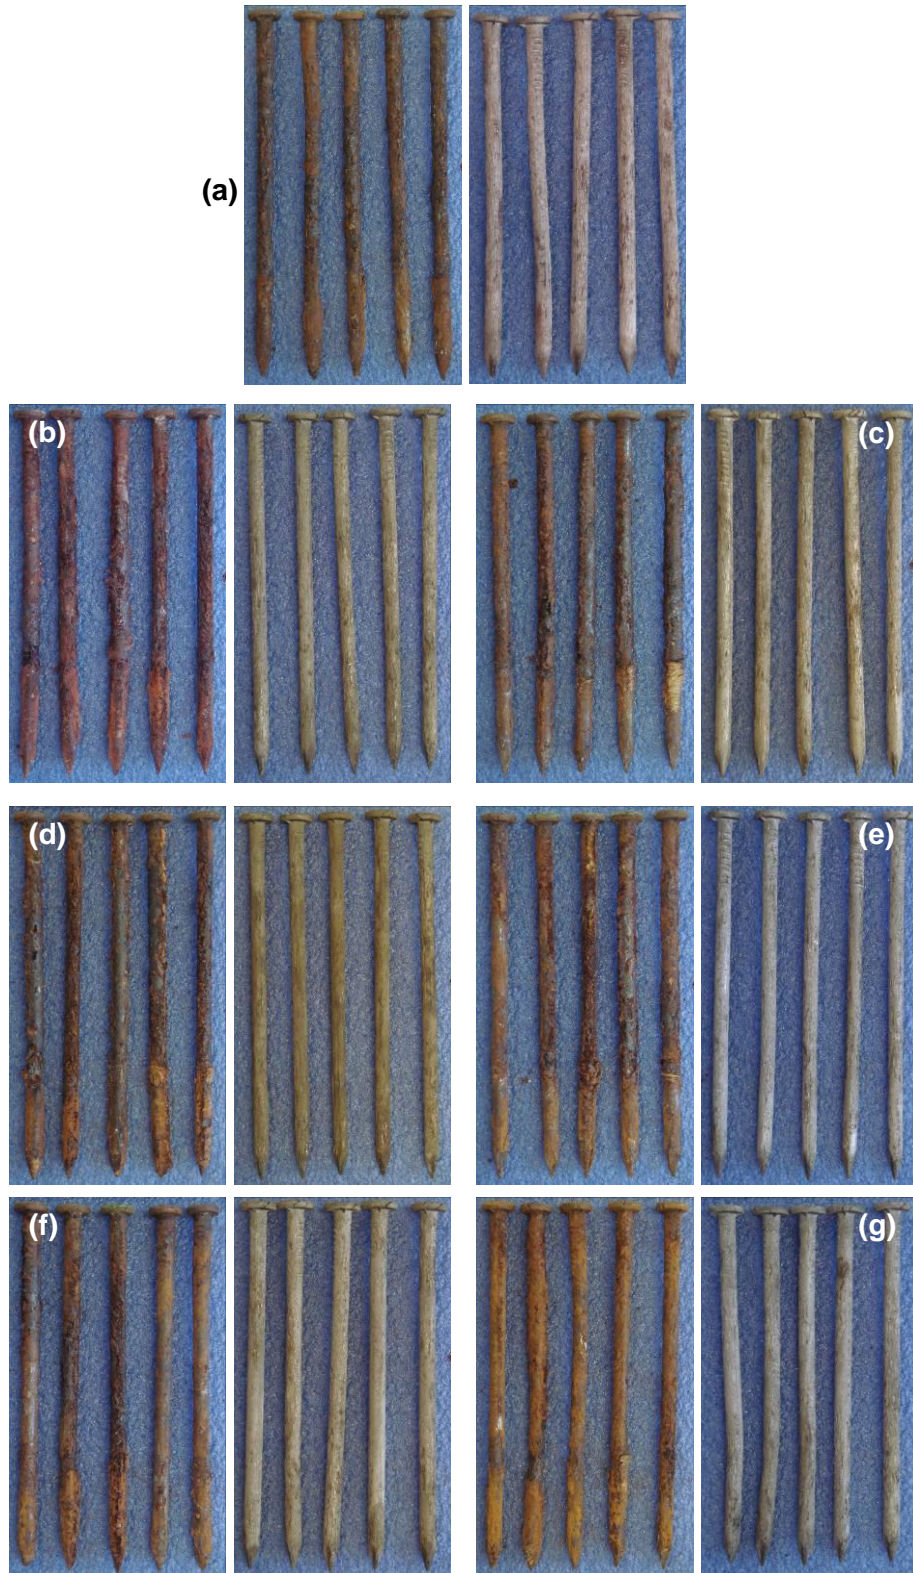
Figure 21: Surface morphology of mild steel nails retrieved from the top part of the timber gate structure exposed at Judgeford site for three years – (a) untreated, (b) H3 CCA, (c) H4 CCA, (d) H3 CuAz, (e) H4 CuAz, (f) H3 ACQ and (g) H4 ACQ

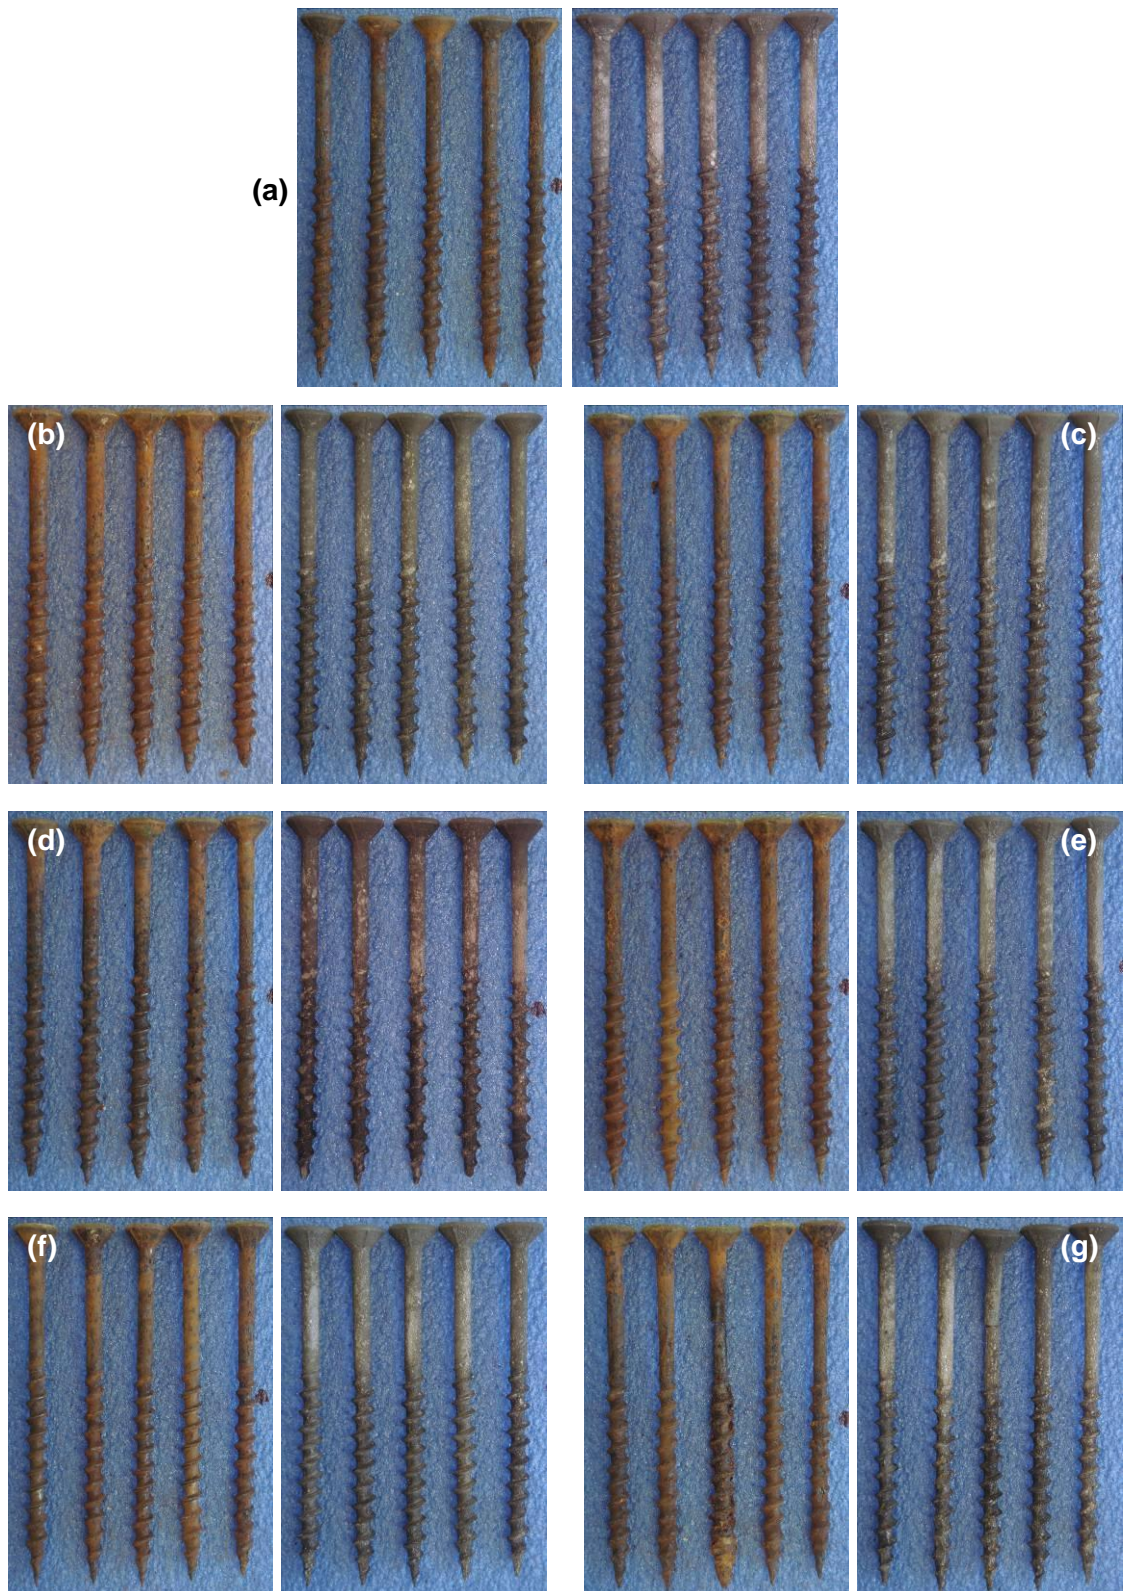
Figure 22: Surface morphology of mild steel screws retrieved from the top part of the timber gate structure exposed at Judgeford site for three years – (a) untreated, (b) H3 CCA, (c) H4 CCA, (d) H3 CuAz, (e) H4 CuAz, (f) H3 ACQ and (g) H4 ACQ

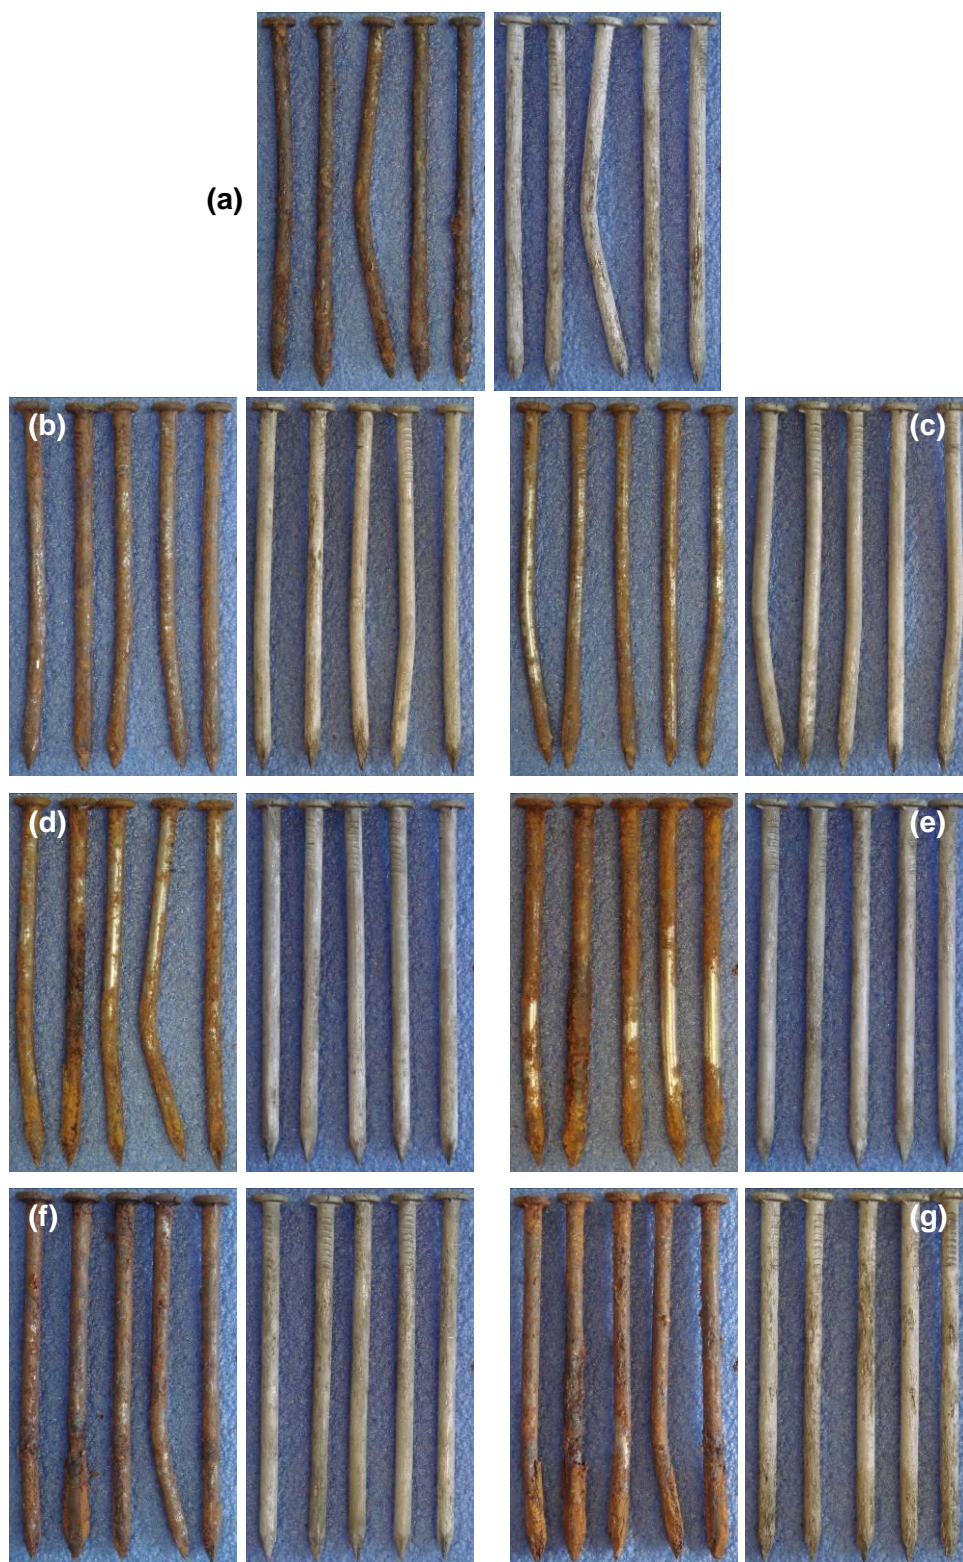
Figure 23: Surface morphology of mild steel nails retrieved from the lower (side) part of the timber gate structure exposed at Judgeford site for three years – (a) untreated, (b) H3 CCA, (c) H4 CCA, (d) H3 CuAz, (e) H4 CuAz, (f) H3 ACQ and (g) H4 ACQ

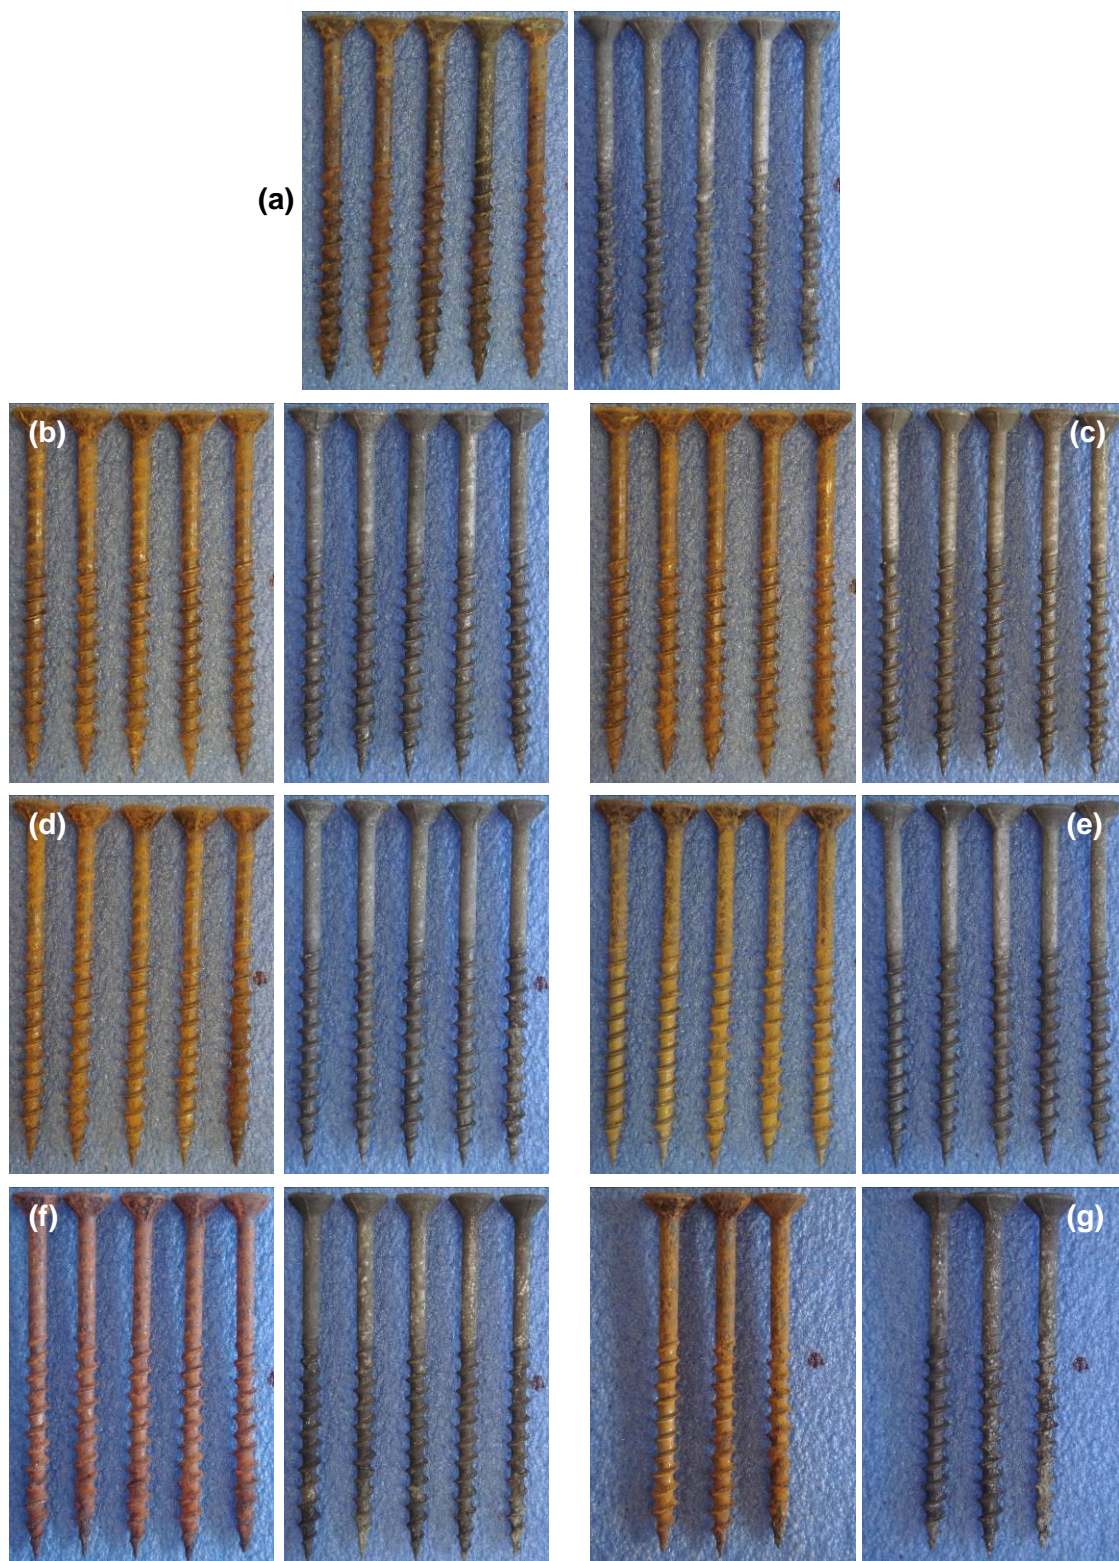
Figure 24: Surface morphology of mild steel screws retrieved from the lower (side) part of the timber structure exposed at Judgeford site for three years – (a) untreated, (b) H3 CCA, (c) H4 CCA, (d) H3 CuAz, (e) H4 CuAz, (f) H3 ACQ and (g) H4 ACQ

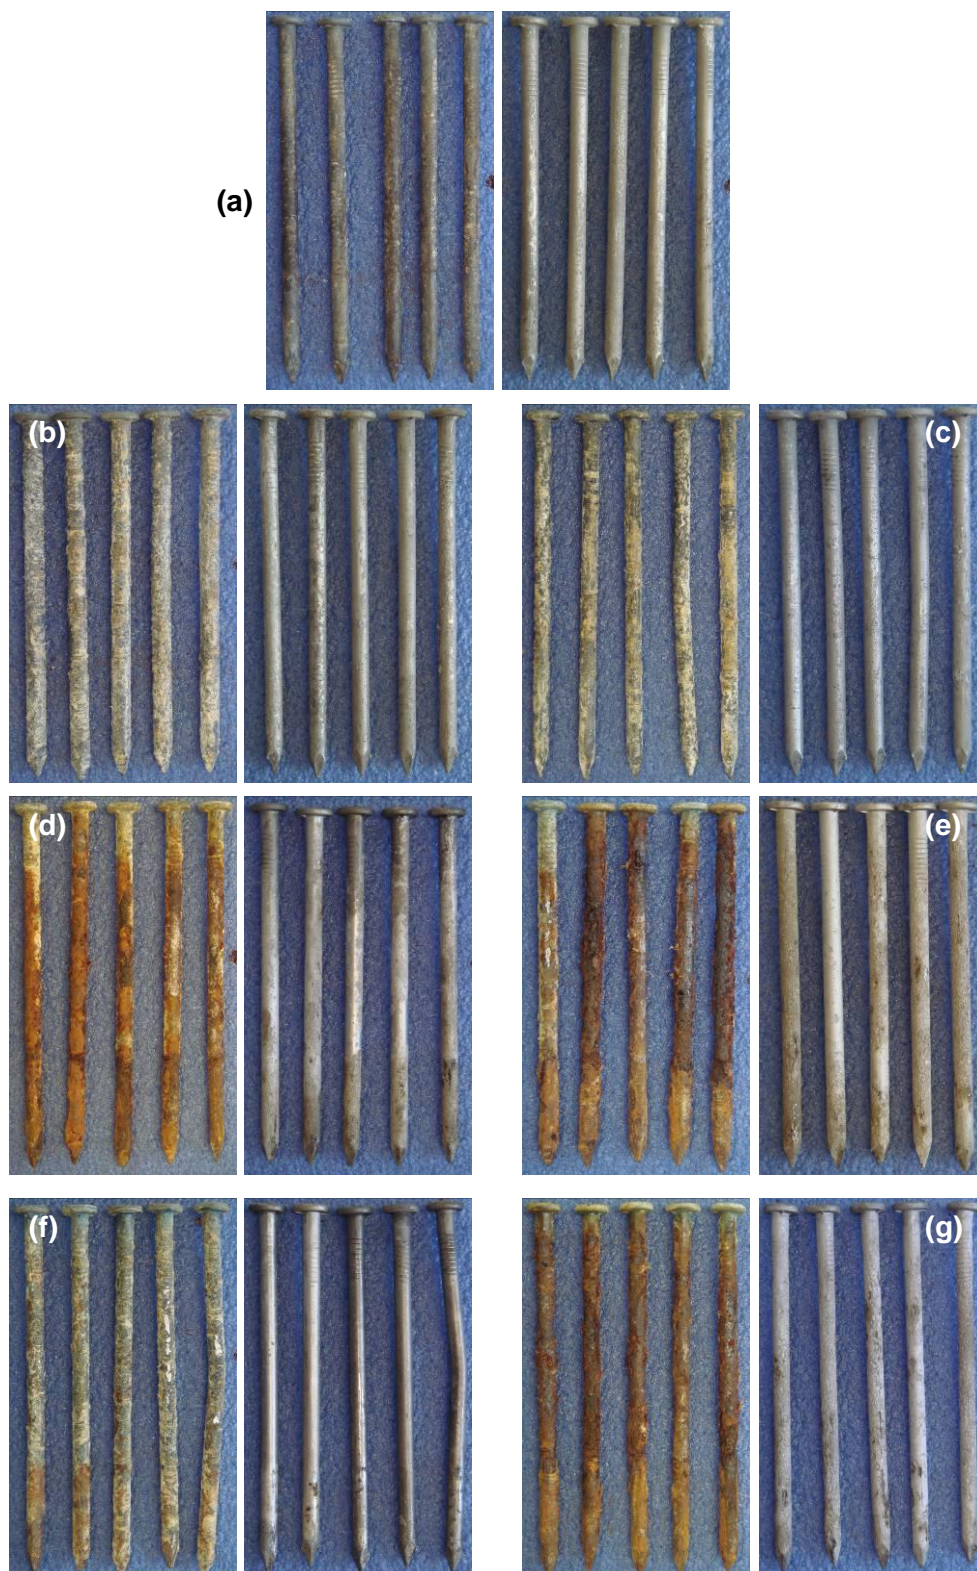
Figure 25: Surface morphology of hot dip galvanised nails retrieved from the top part of the timber gate structure exposed at Judgeford site for three years – (a) untreated, (b) H3 CCA, (c) H4 CCA, (d) H3 CuAz, (e) H4 CuAz, (f) H3 ACQ and (g) H4 ACQ

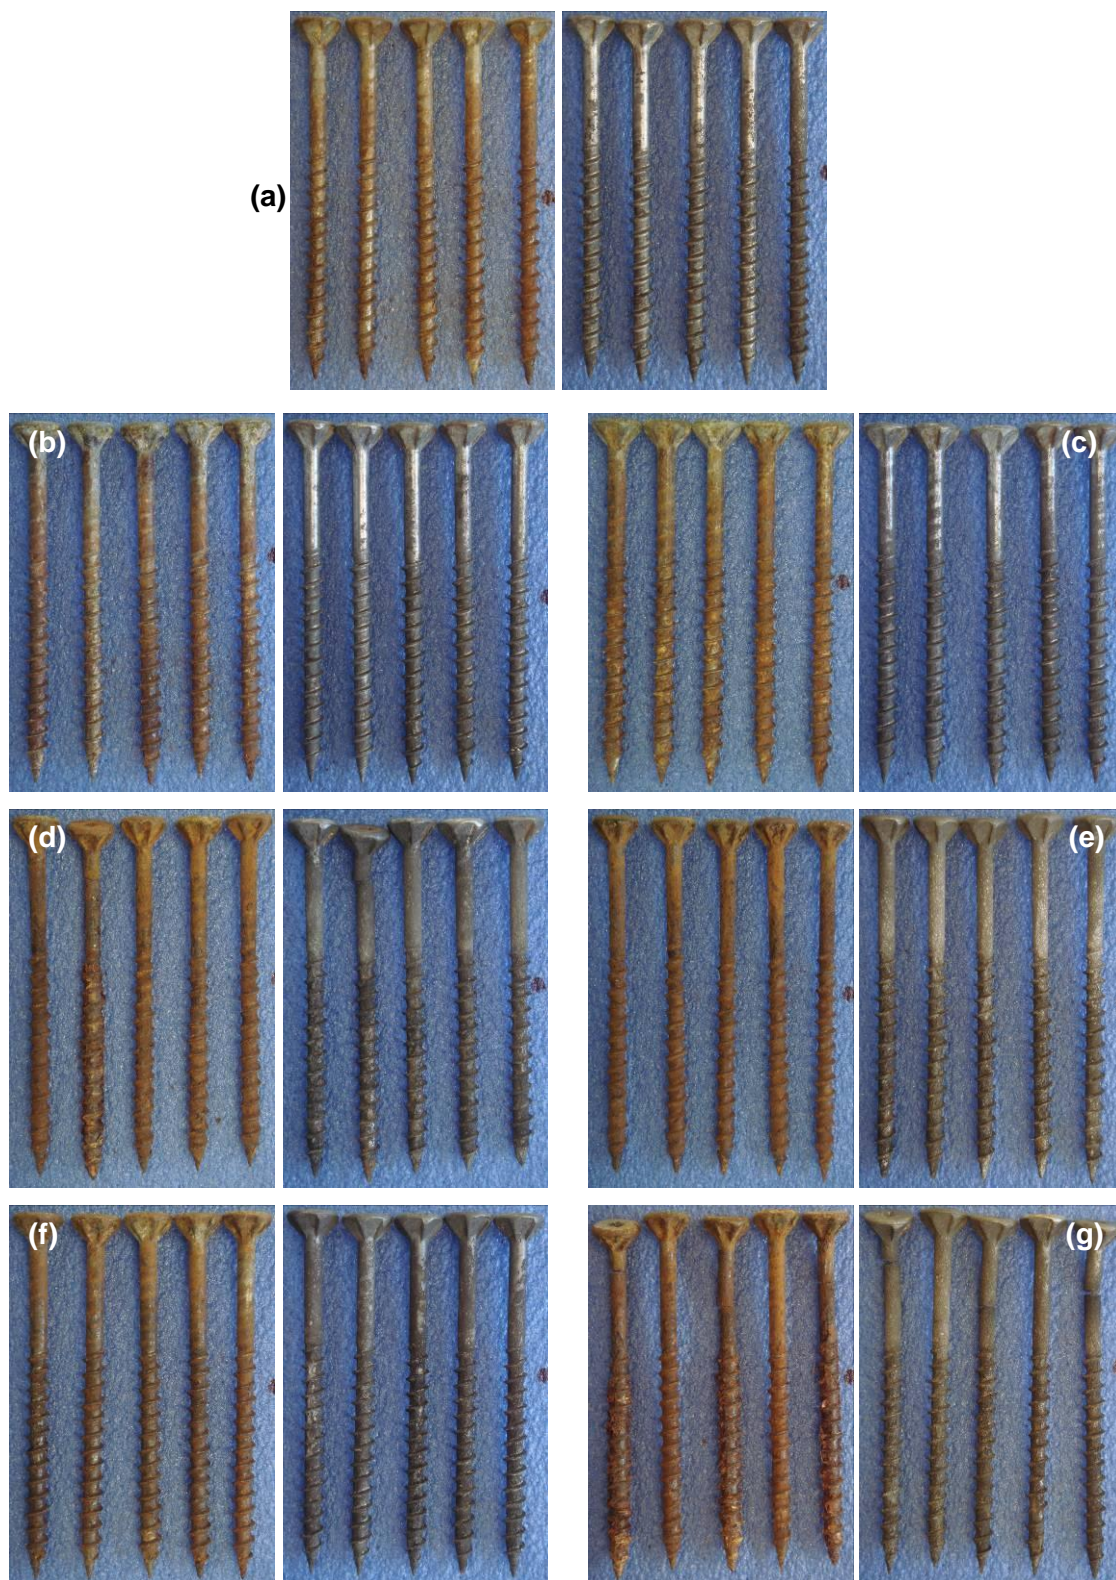
Figure 26: Surface morphology of mechanically-plated screws retrieved from the top part of the timber gate structure exposed at Judgeford site for three years – (a) untreated, (b) H3 CCA, (c) H4 CCA, (d) H3 CuAz, (e) H4 CuAz, (f) H3 ACQ and (g) H4 ACQ

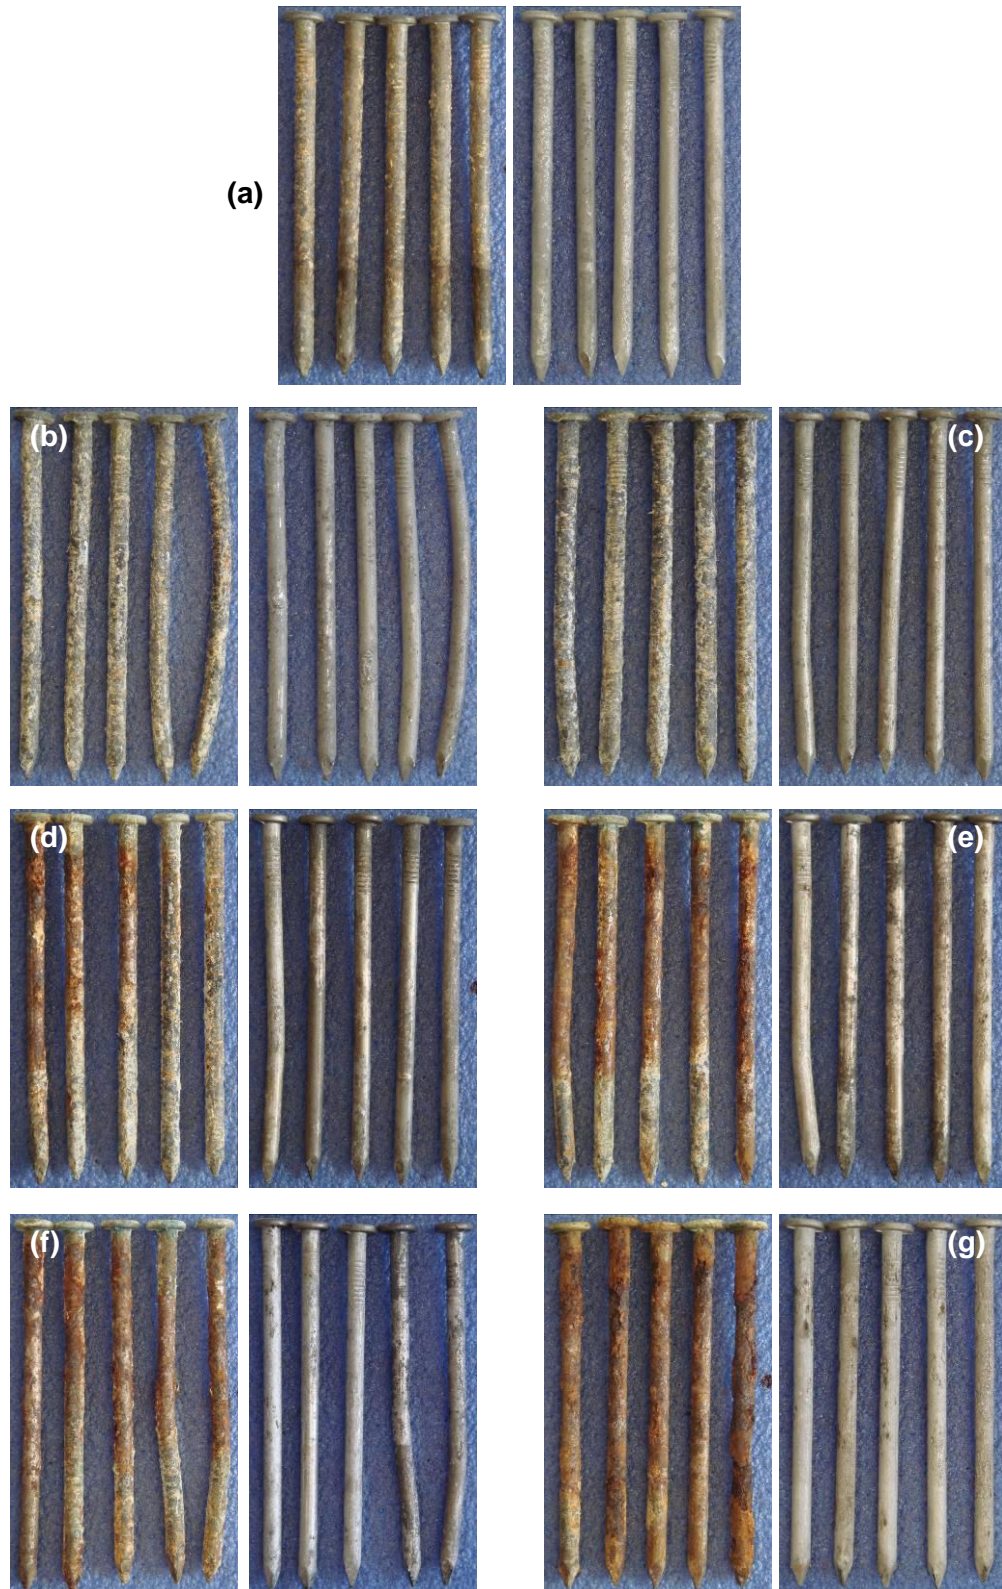
Figure 27: Surface morphology of hot dip galvanised nails retrieved from the lower (side) part of the timber gate structure exposed at Judgeford site for three years – (a) untreated, (b) H3 CCA, (c) H4 CCA, (d) H3 CuAz, (e) H4 CuAz, (f) H3 ACQ and (g) H4 ACQ
