STUDY REPORT

SR 241 (2011)

Corrosion of Fasteners in Treated Timber

BRANZ Study Report SR 241

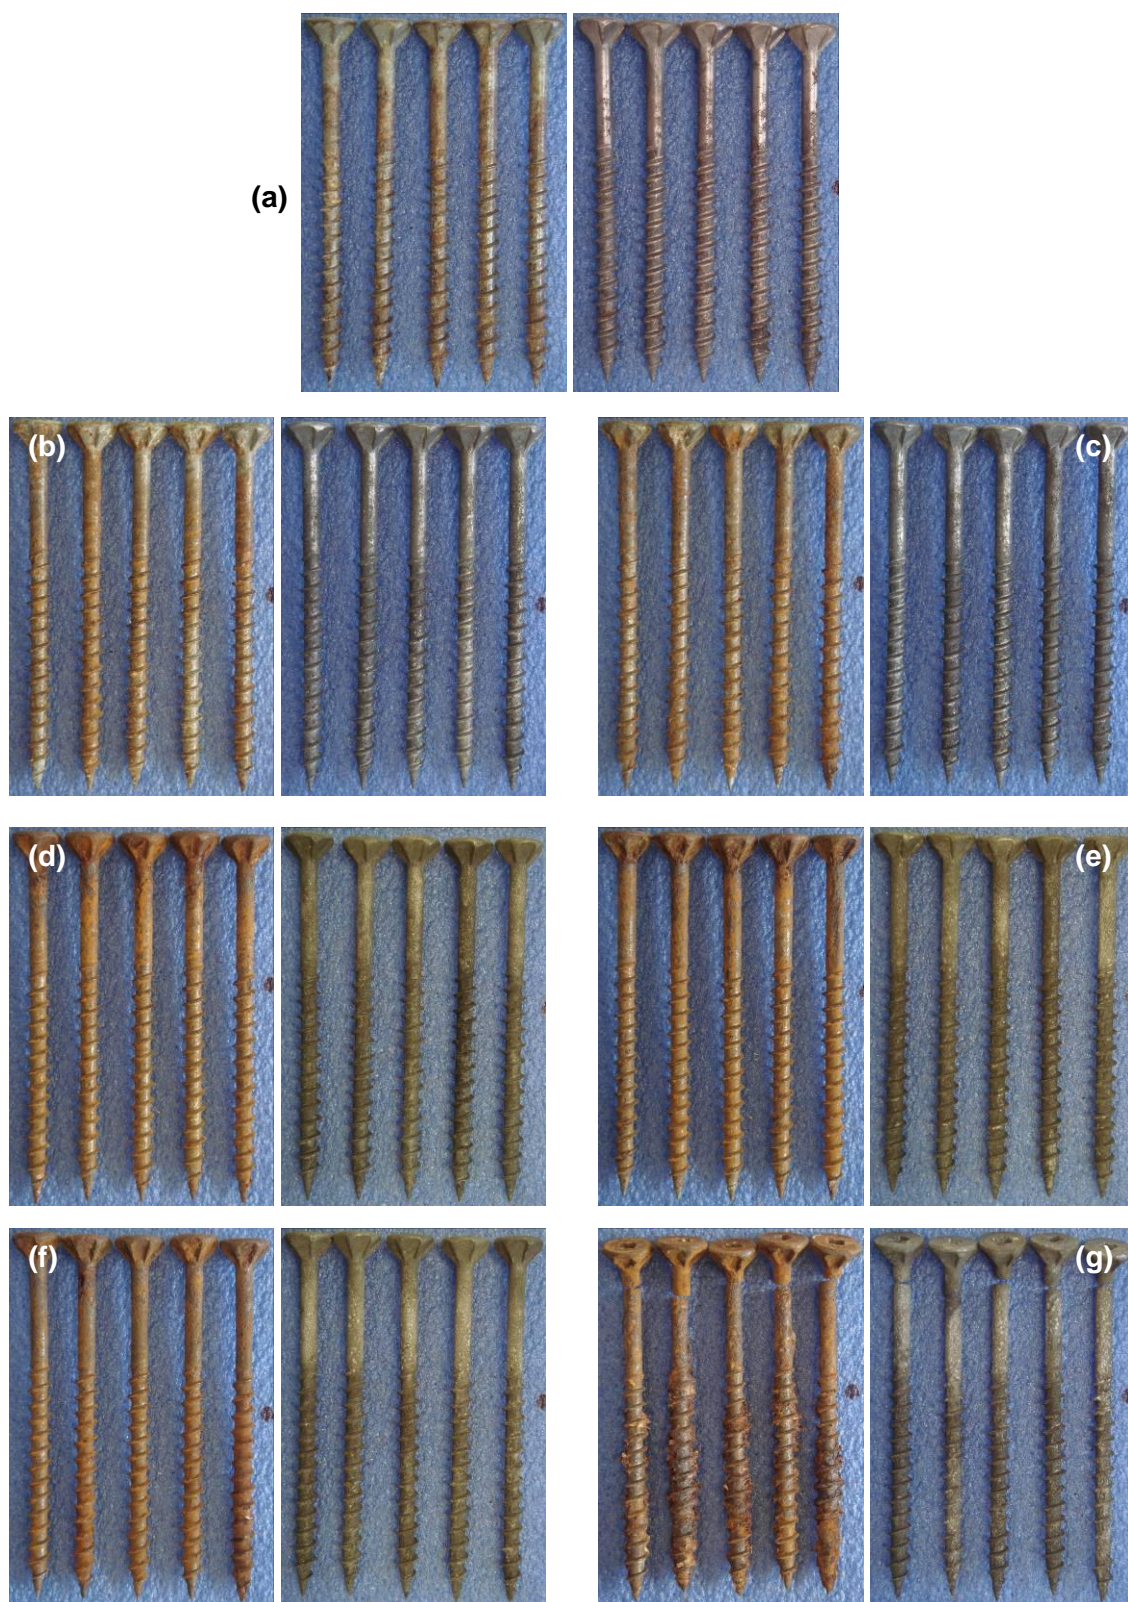
Figure 28: Surface morphology of mechanically-plated screws retrieved from the lower (side) part of the timber gate structure exposed at Judgeford site for three years – (a) untreated, (b) H3 CCA, (c) H4 CCA, (d) H3 CuAz, (e) H4 CuAz, (f) H3 ACQ and (g) H4 ACQ

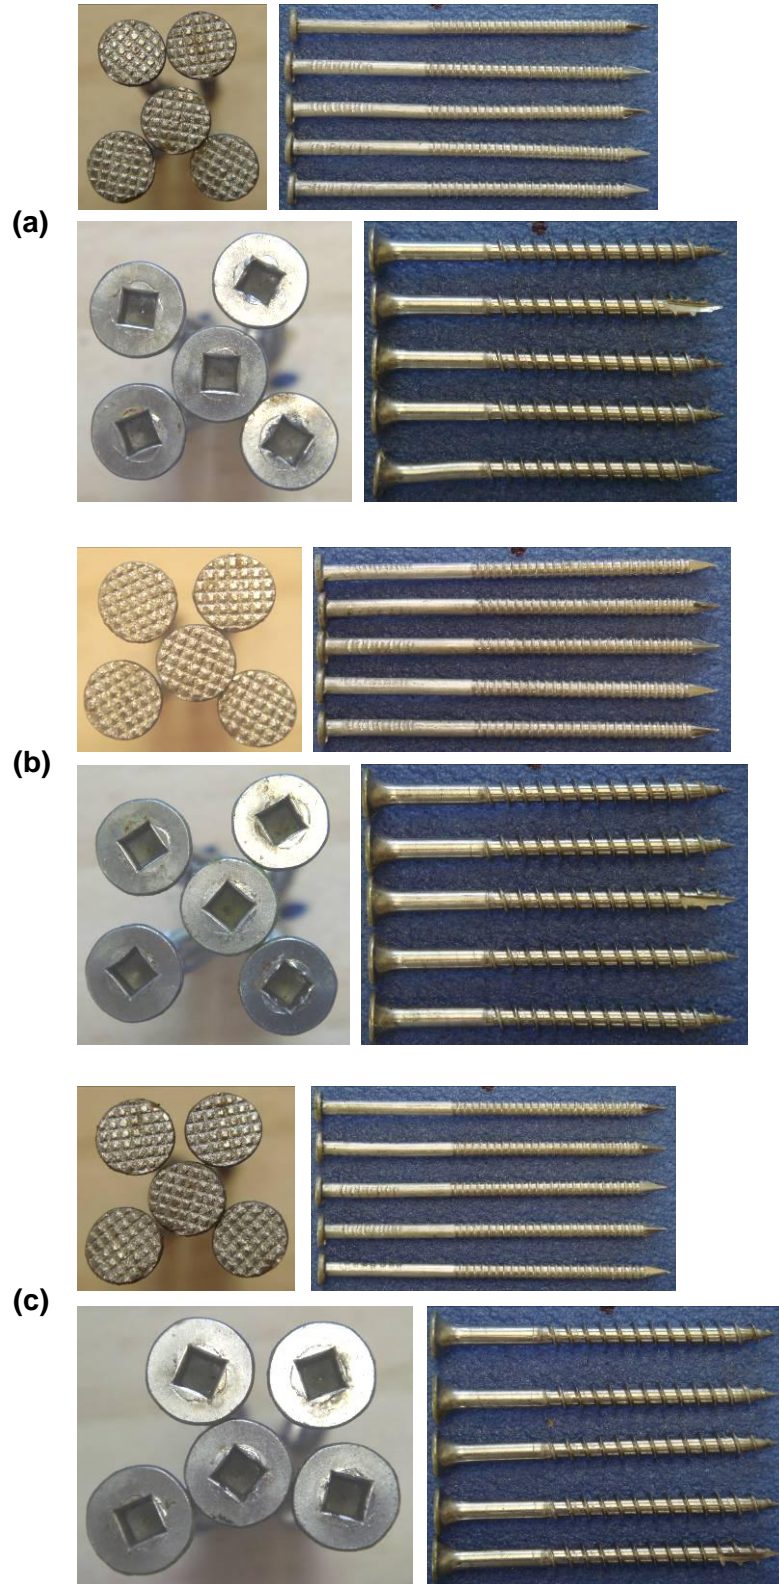
Figure 29: Typical surface morphology of stainless steel fasteners retrieved from the top part of the timber gate structure exposed at Judgeford site for three years – (a) H4 CCA, (b) H4 CuAz and (c) H4 ACQ

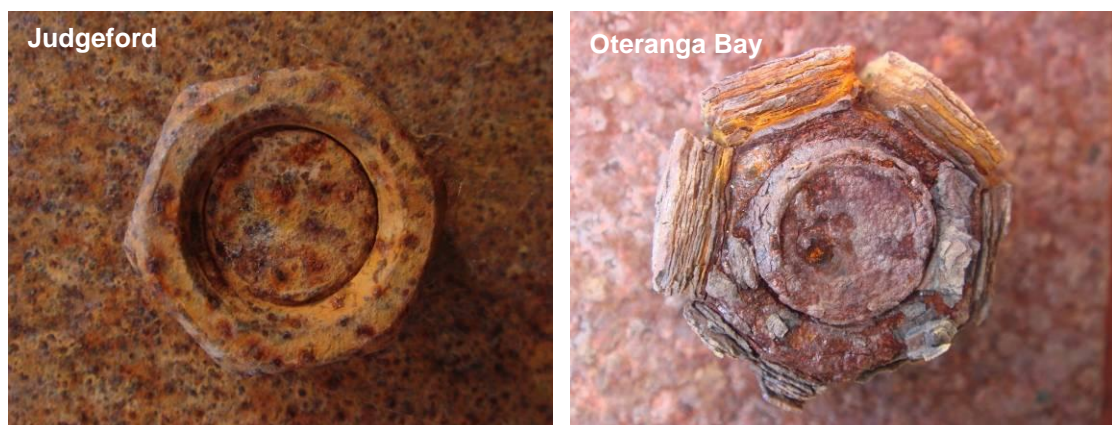
Figure 34: Mild steel nuts exposed at Judgeford and Oteranga Bay for three years

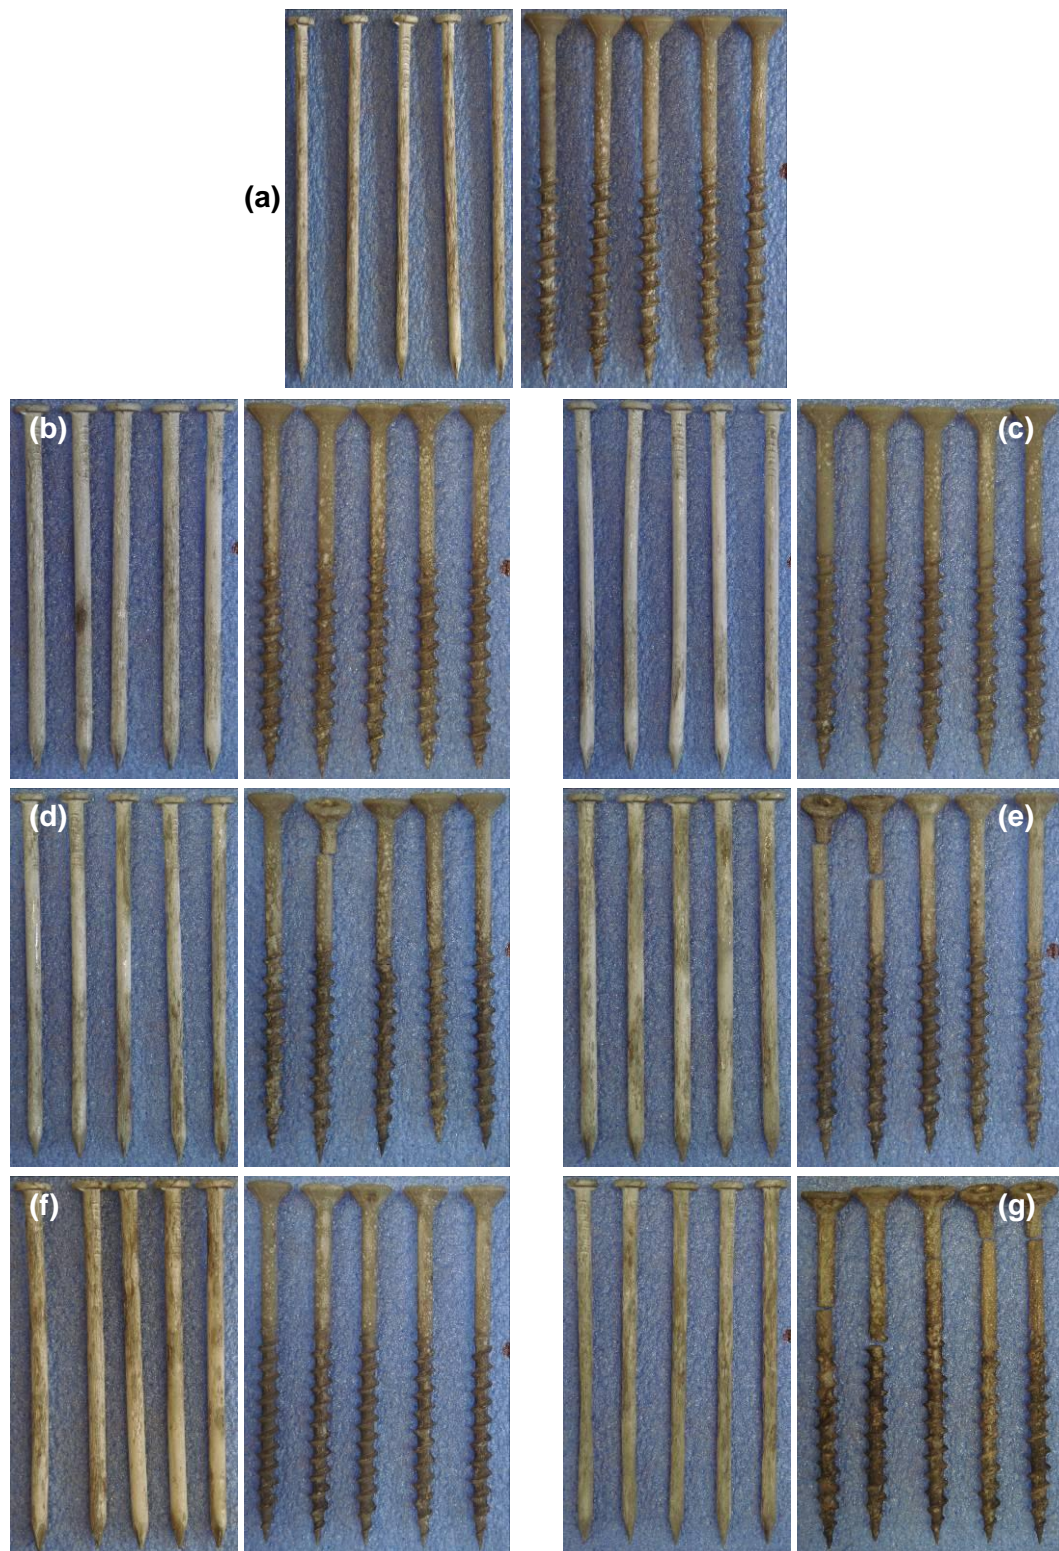
Figure 35: Surface morphology of mild steel fasteners retrieved from the top part of the timber gate structure exposed at Oteranga Bay for three years – (a) untreated, (b) H3 CCA, (c) H4 CCA, (d) H3 CuAz, (e) H4 CuAz, (f) H3 ACQ and (g) H4 ACQ

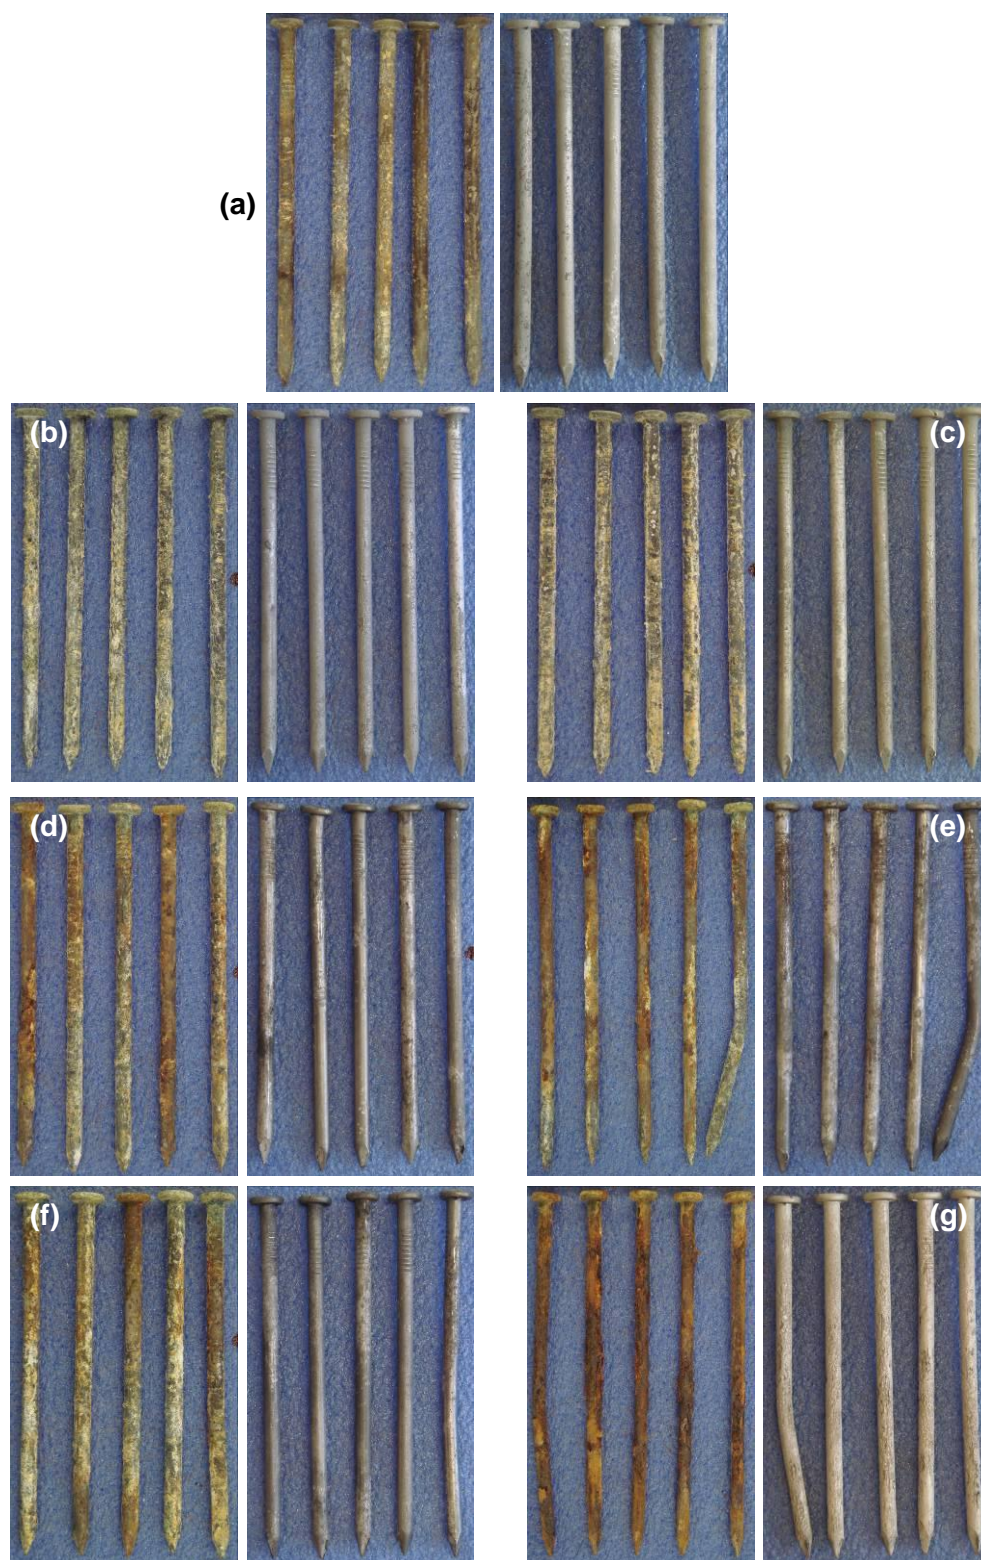
Figure 36: Surface morphology of hot dip galvanised nails retrieved from the top part of the timber gate structure exposed at Oteranga Bay for three years – (a) untreated, (b) H3 CCA, (c) H4 CCA, (d) H3 CuAz, (e) H4 CuAz, (f) H3 ACQ and (g) H4 ACQ

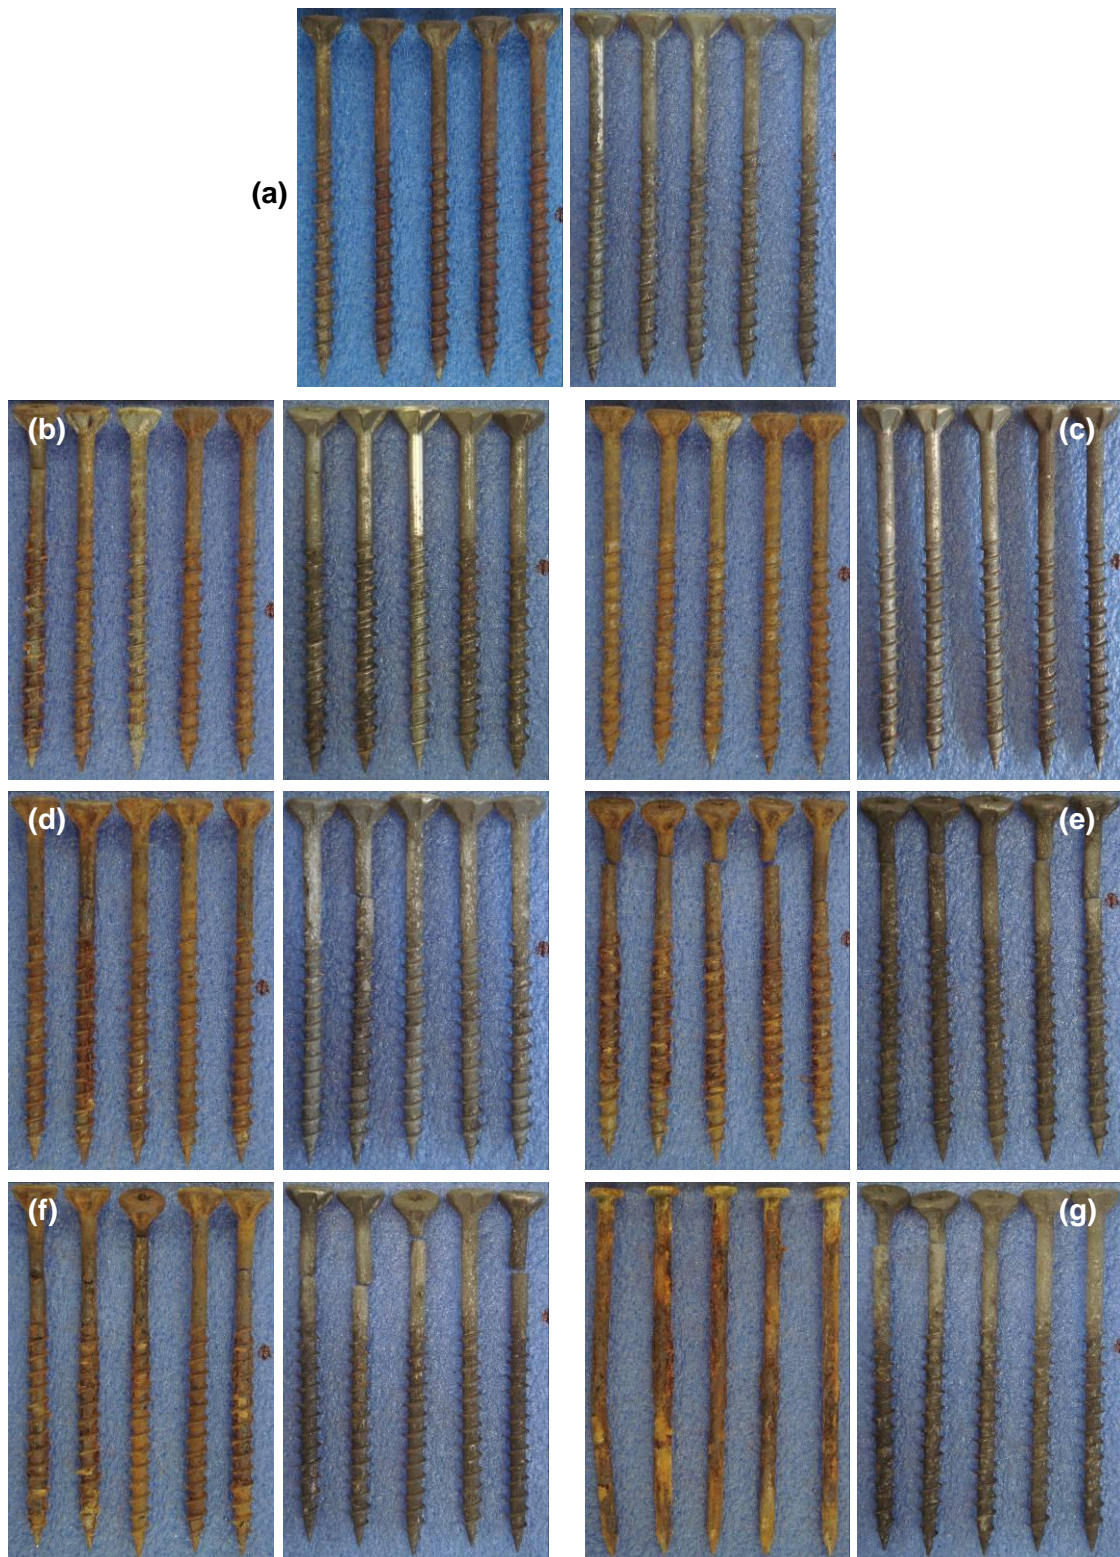
Figure 37: Surface morphology of mechanically-plated screws retrieved from the top part of the timber gate structure exposed at Oteranga Bay for three years – (a) untreated, (b) H3 CCA, (c) H4 CCA, (d) H3 CuAz, (e) H4 CuAz, (f) H3 ACQ and (g) H4 ACQ

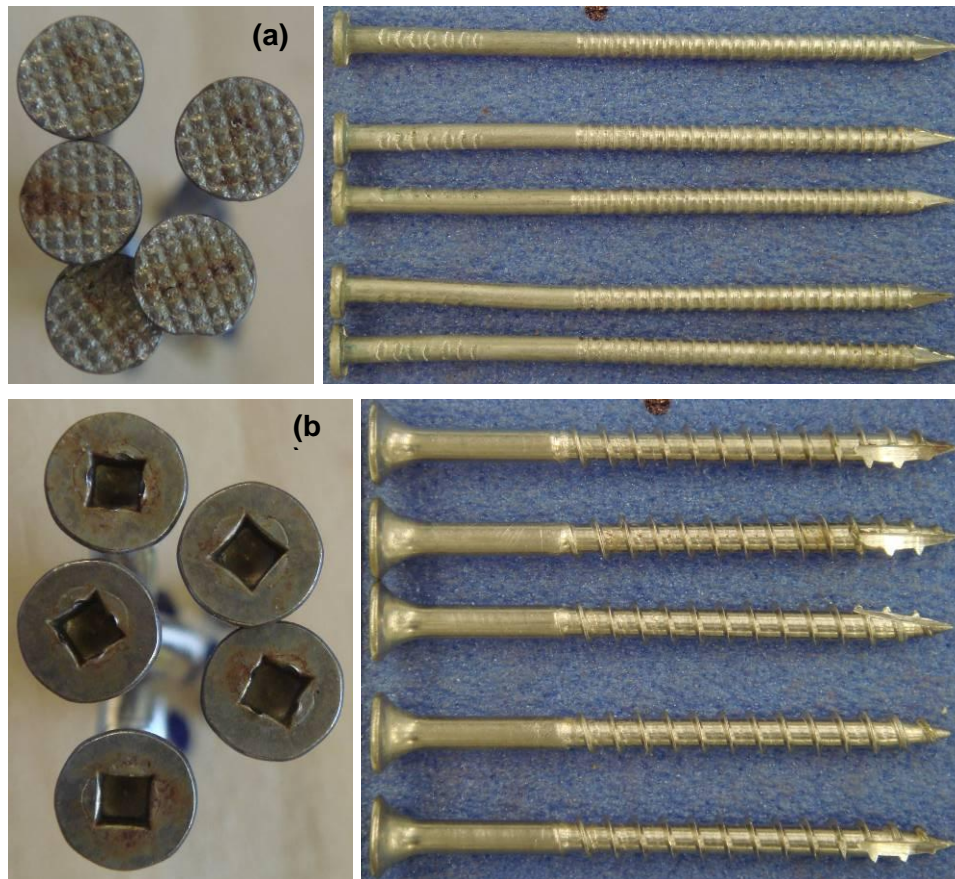
Figure 38: Typical surface morphology of stainless steel fasteners retrieved from the top part of the H4 ACQ treated timber gate structure exposed at Oteranga Bay for three years

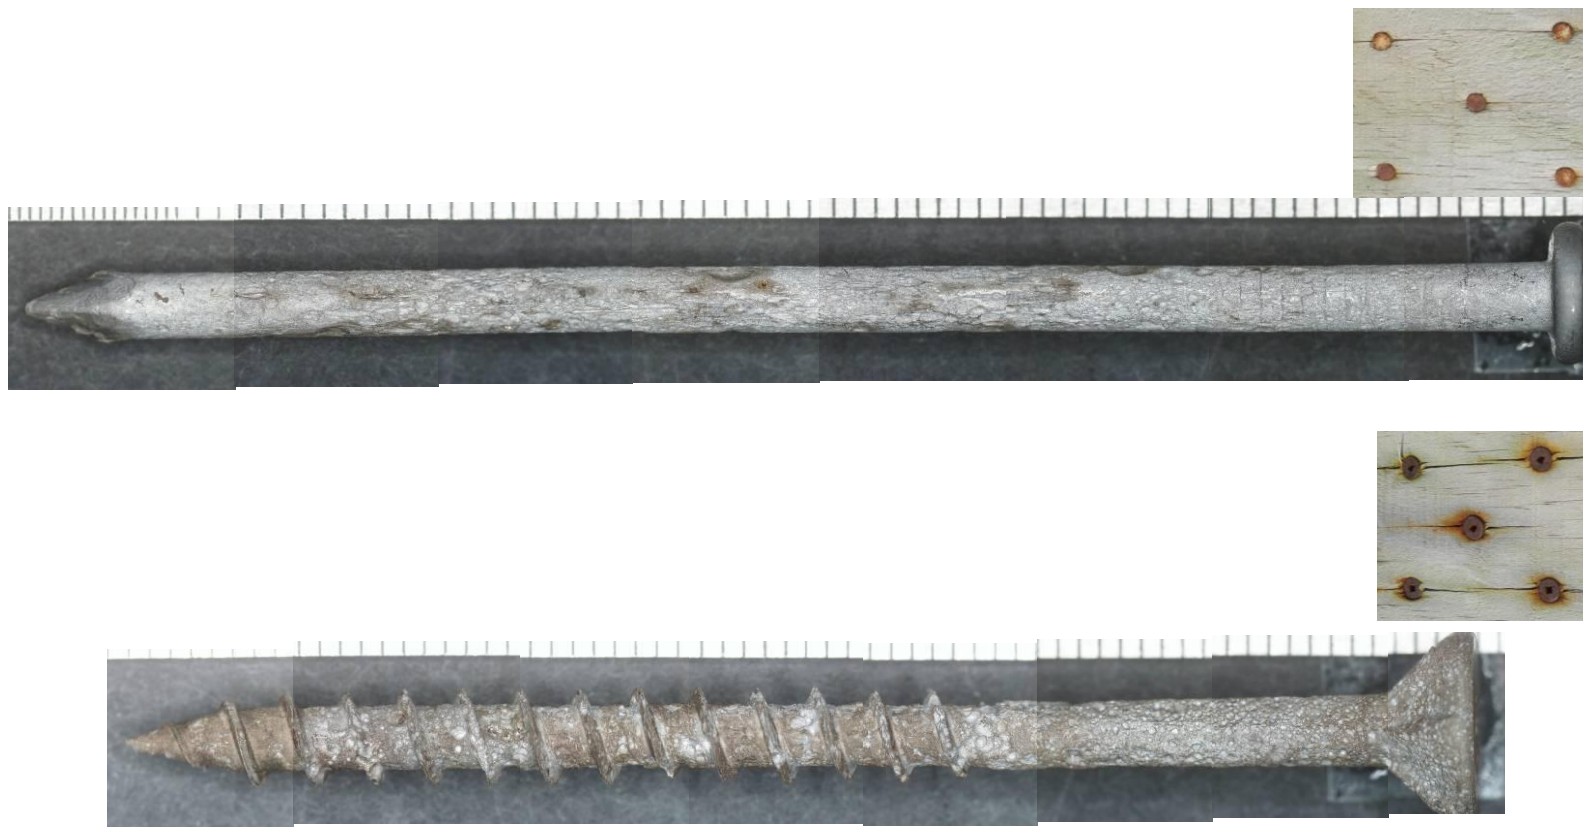
Figure 55: Cleaned zinc-coated fasteners retrieved from H4 ACQ treated timbers exposed at Oteranga Bay for three years. The zinc coating on the head was consumed and then iron-rich rust was formed. However, it must be noted that corrosion on the body section was still more severe than on the head

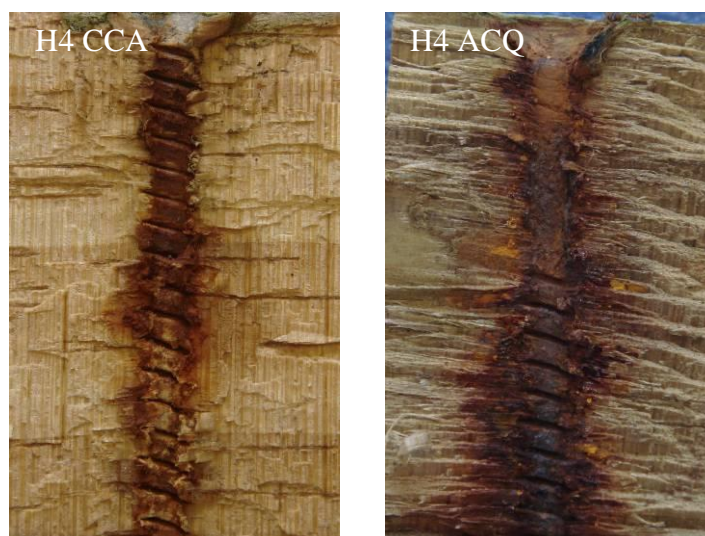
Figure 56: Iron stains formed by corrosion of mechanically-plated screws in H4 CCA and H4 ACQ treated timbers exposed at Judgeford for three years
