Walker Property Evaluation Services

INSPECTION OVERVIEW

Client: The Investment Group
Inspection Address: 111 Shop-Till You Drop Drive, Milpitas, CA 94403
Inspection Date: 1/2/2012
Inspected by: Skip Walker

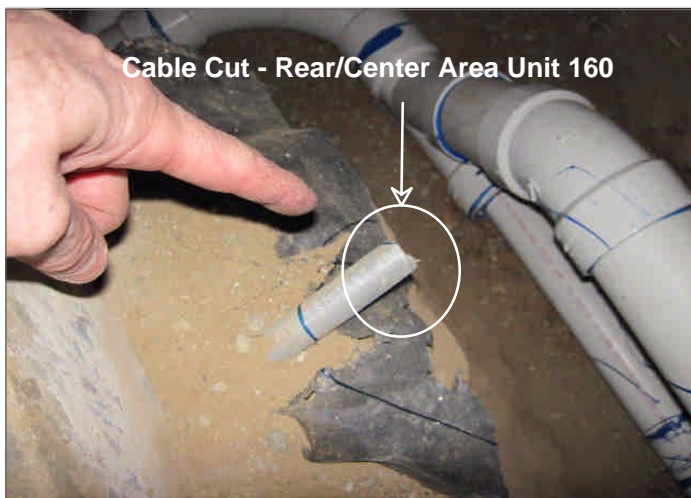
- q 1.6 - There is an under-slab electrical cable that was damaged or cut at Unit 160. I recommend that a qualified electrical contractor evaluate and service as needed.

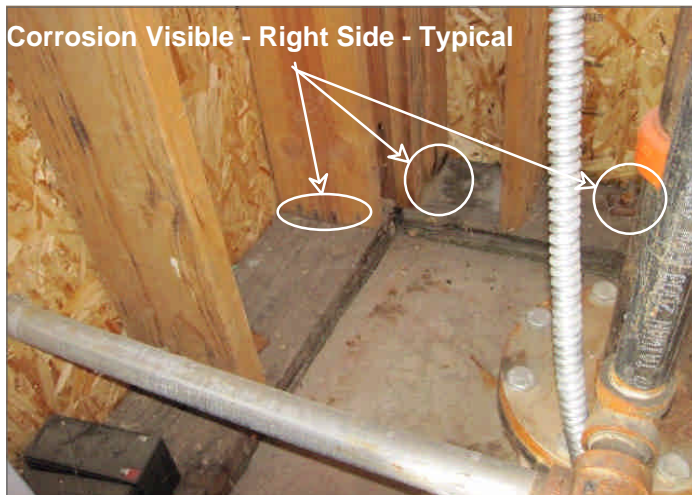
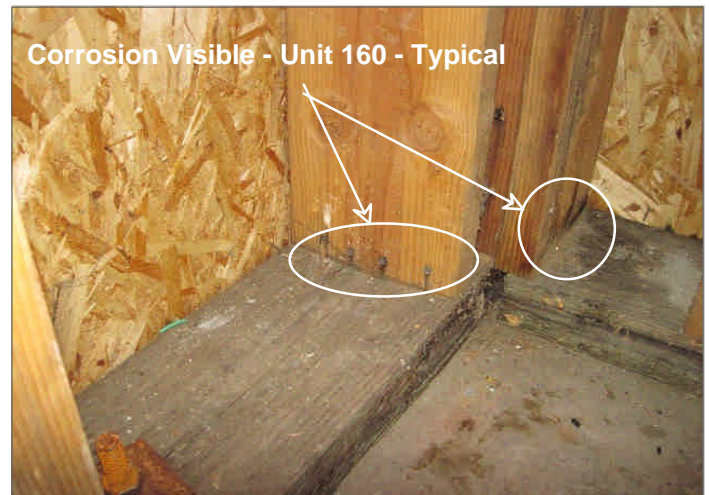
In the course of this inspection, some corrosion was observed at the exposed portions of the metal fasteners and or metal connectors used on the mudsill. I can not positively confirm that the pressure treated lumber is a type that requires the use of these newer highly corrosion resistant fasteners, metal brackets, bolts, washers, screws and or nails. It is beyond the scope of a visual general property inspection to verify that a given installation conforms to the manufacturers installation instructions and or the plans as designed and approved by the local authority having jurisdiction. The installation recommendations will vary widely depending on the specific chemical treatment used on any of the newer pressure treated type lumber, the metal fastener or bolt manufacturers recommendations, the design professionals recommendations and will vary significantly by building departments own local requirements. It will be important to monitor all fasteners for unusually high amounts of and or additional corrosion. If atypical amounts of corrosion are observed, it will be important to contact a qualified general contractor familiar with this issue to fully evaluate the framing and support system. I recommend that the installation be further evaluated both now and on an ongoing basis to ensure proper performance of the installation. Interested parties may also wish to refer to www.strongtie.com and www.osmose.com for additional information.

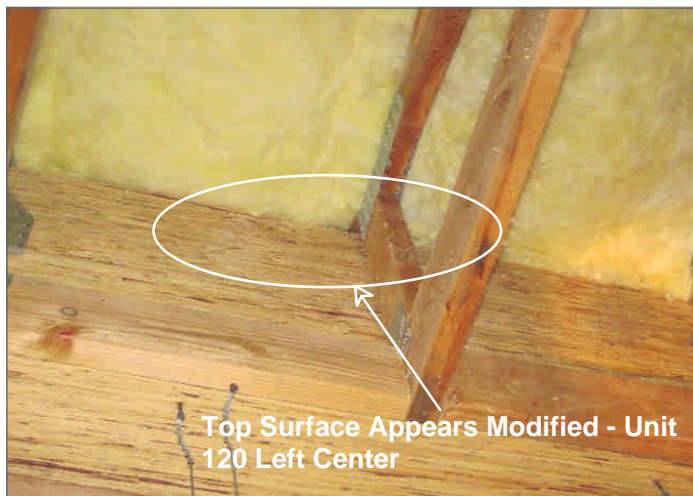
PSL - Cut Modified - *Continued*

- 1.19 - One or more of the ParaLam/PSL/Engineered Wood framing components appear to have been cut modified or altered. These members are engineered components that are manufactured off-site. No modifications, alterations or repairs are permitted to an engineered system unless the modifications are made in accordance with the manufacturers installation instructions or a registered design professional. Any repairs/modifications must also be reviewed and accepted by the local jurisdiction having authority. It is recommended that all modified engineered components be further evaluated by a registered design professional. Any necessary repairs should be completed by a qualified general contractor.

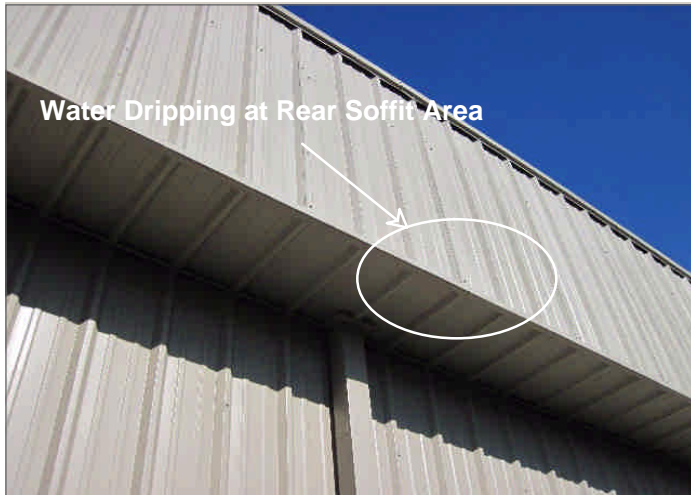
- q 2.12 - There is water dripping intermittently and indications of prior moisture at the base of the rear soffit area at Unit 130. It is unclear whether this is due to issues with the adjacent roof drain or from the improperly vented tenant clothes dryer in the hair salon (Noted Elsewhere). I recommend that a

qualified general contractor evaluate and service as necessary. These areas should be made fully accessible when repairs are undertaken. While I make every effort to identify potential problem areas during this limited visual inspection, the nature and full extent of any issues may not be completely understood until the area is made fully accessible. It is possible that damage may exist elsewhere that is not visibly manifested in any way as well. The scope of this inspection is strictly limited to the readily visible portions of the building.

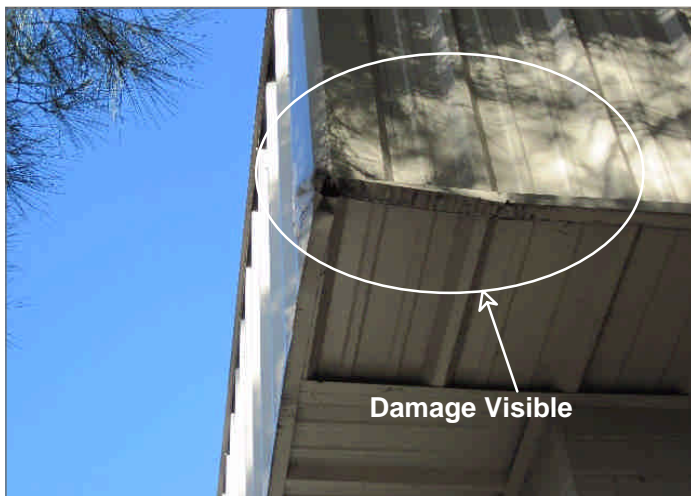
- 2.13 - There are one or more mechanically damaged/improperly sealed penetrations in the exterior cladding that should be caulked, sealed and or serviced as needed to prevent moisture infiltration. I recommend further evaluation and service as needed by a qualified trades specialist.

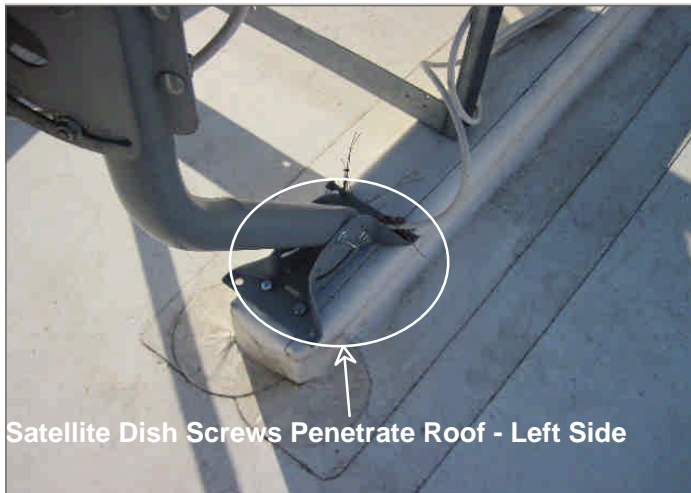
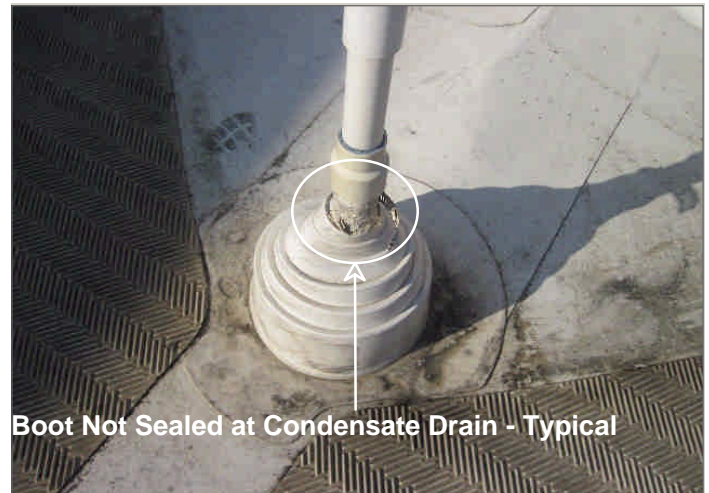
- 3.8 - There are various improperly sealed penetrations that should be serviced. I recommend that a qualified roofing contractor further evaluate the roof and seal/service all penetrations as needed to ensure proper performance.

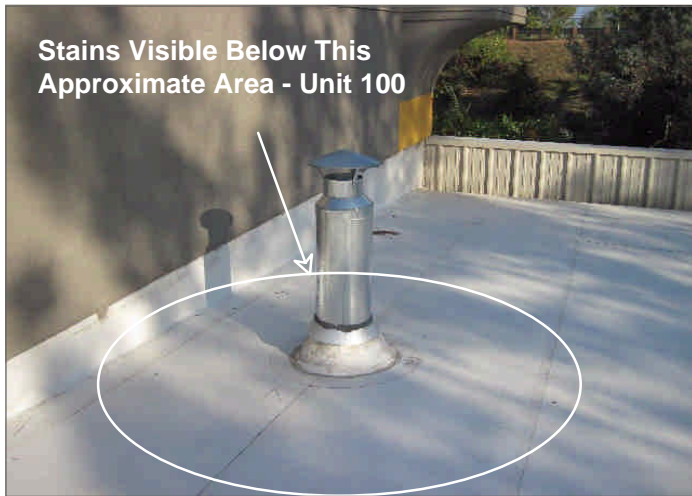
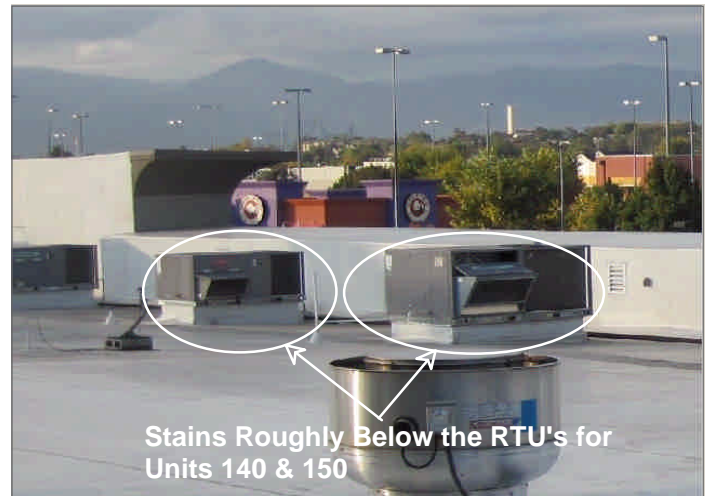
There are indications of prior moisture-dry stains inside the interior areas - Further Evaluate Roof - *Continued*

- 3.9 - As noted elsewhere, there are indications of prior moisture/dry stains visible at the interior areas. This may be the result of roof issues or HVAC system problems. Leaks can be difficult to confirm even when raining. Interested parties should inquire of the sellers/occupants as to the nature of the interior stains and or any known issues with the roof as they often have the most intimate knowledge of the property history and such issues. I recommend that the roof and HVAC systems be further evaluated by an appropriate/qualified contractor prior to the removal of transaction contingencies.

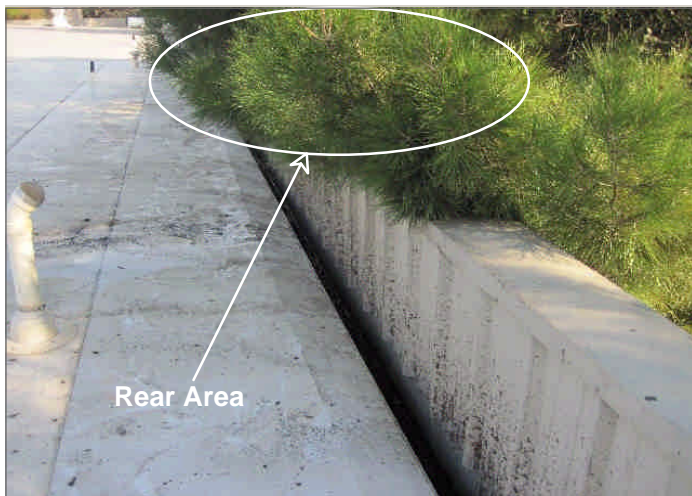
- 3.10 - There are one or more trees or shrub branches overhanging and or in contact with the roof. Tree branches may rub the roof surface during windy or stormy periods. This may result in damage to the roof coating/surface and may negatively impact the roofs service-life. I recommend that a qualified arborist trim the branches. Periodic maintenance will be required as well to maintain proper clearances. Additionally, a qualified roofing contractor should periodically inspect, clean and service the roof to insure trouble-free performance.

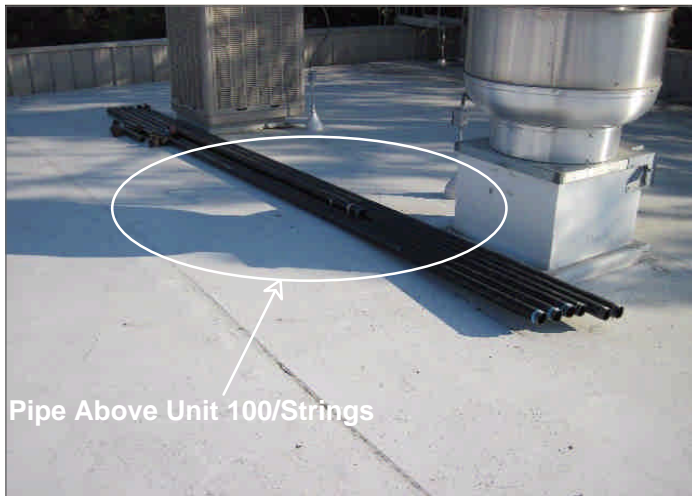
Abandoned Pipe Equipment - *Continued*

- 3.11 - There is apparently abandoned/unused equipment, piping, etc. that should be removed. I recommend that the roof be cleared of any obstruction, debris etc as this may inhibit proper drainage. Any such areas should be made accessible and further evaluated by a qualified roofing contractor.

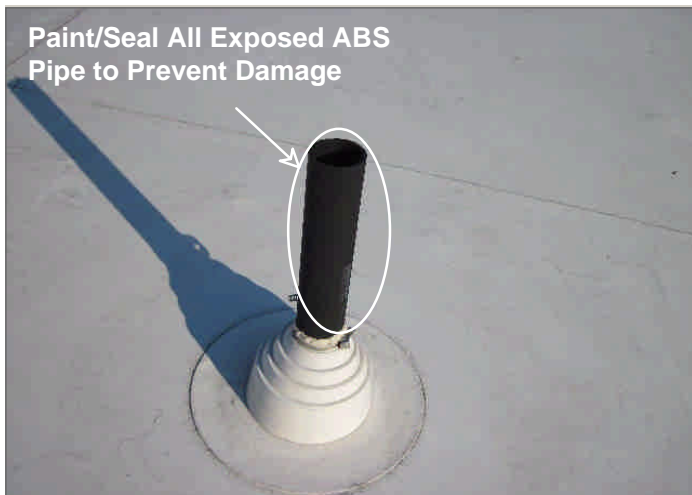
- 3.13 - The exposed roof area ABS vent pipes do not have a protective coating installed and should be serviced. ABS pipe is not designed for prolonged exposure to sunlight. This will lead to deterioration of the material. Generally speaking, the manufacturer will recommend a minimum of two coats of a latex based paint for UV protection. I recommend evaluation and service as needed by a qualified trades person.

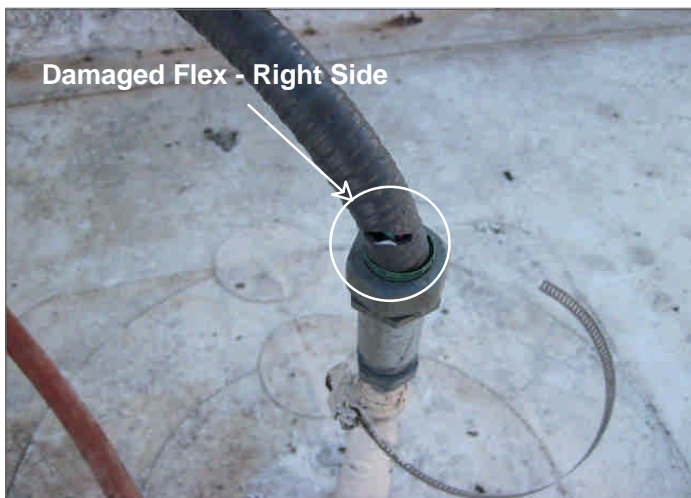
- 3.17 - Portions of the electrical components/conduits appears inadequately secured/supported. Conduit should be properly supported to prevent movement. The conduit should be properly spaced off the roof surface to permit proper drainage. This may pose a safety /trip hazard. All electrical conduit should be secured at appropriate intervals using approved/listed fasteners. I recommend that a qualified electrician evaluate the installation and service as needed.
- 3.18 - There are one or more damaged electrical conduits on the roof. All electrical enclosures, cable and or conduits, etc must be free of damage and weather sealed. I recommend that a qualified electrician evaluate and service as necessary.

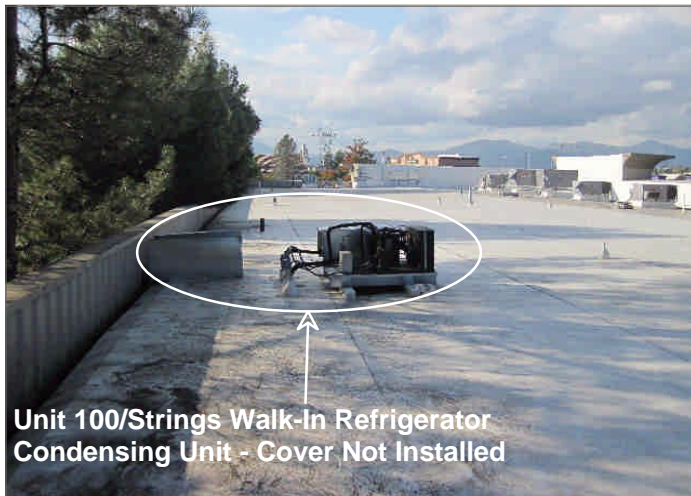
Unit 100/Strings Walk-In Refrigerator
Condensing Unit - Cover Not Installed

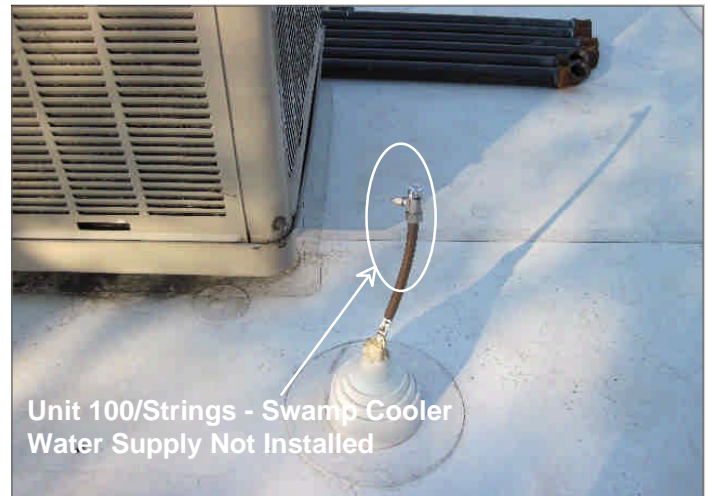
Unit 100/Strings - Swamp Cooler
Water Supply Not Installed

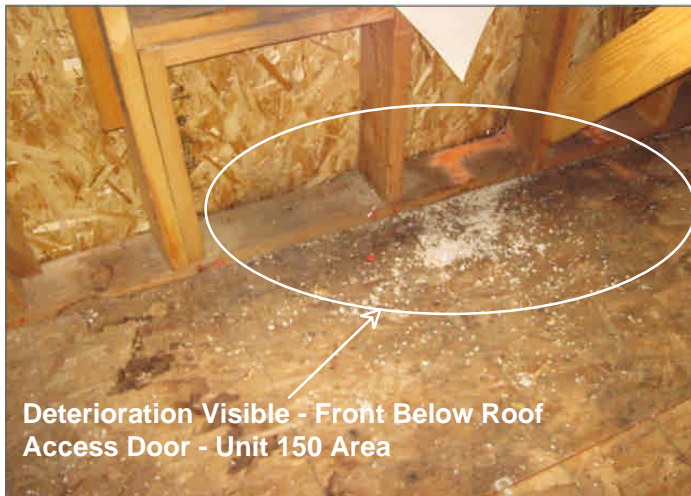
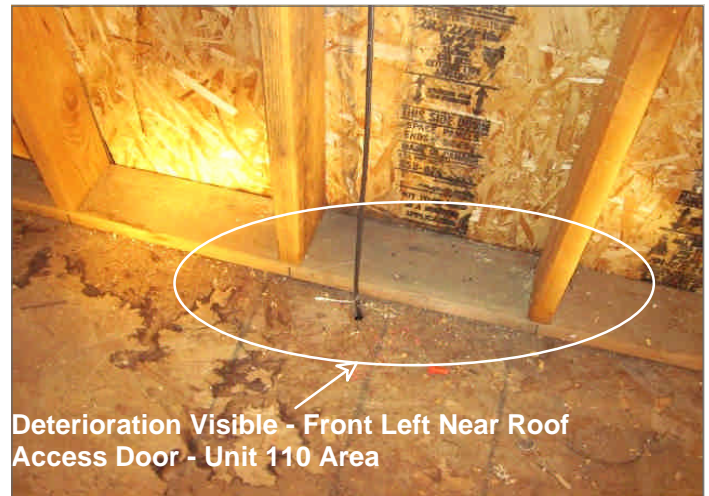
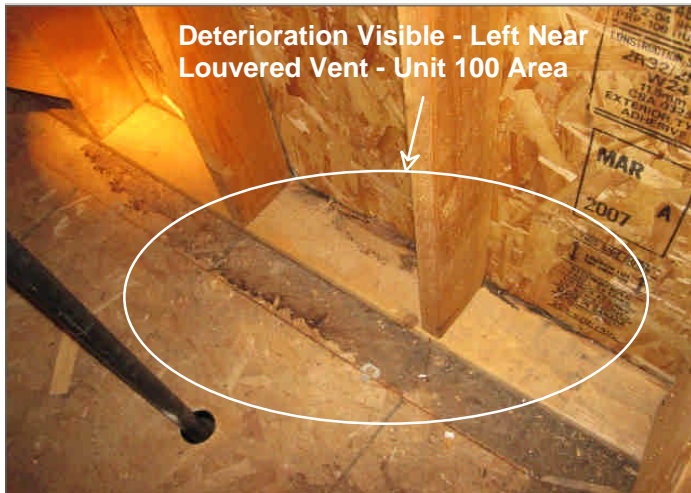
There is moisture related deterioration visible at several areas on the perimeter framing-sheathing - *Continued*

- 3.25 - There is moisture related deterioration visible at several areas on the perimeter framing-sheathing. I recommend the exterior be fully evaluated and serviced as necessary by a qualified general and or roofing contractor.

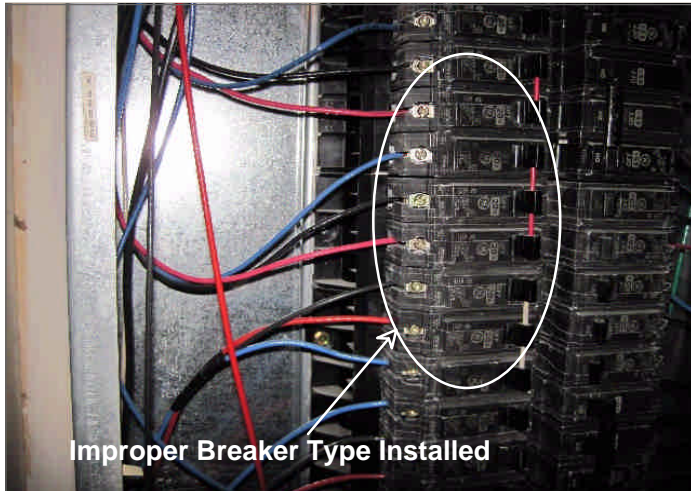
- q 5.34 - Several of the 3 Phase circuits appear improperly installed using 3 single pole 120 VAC breakers. This installation is improper as it would allow one "leg" of 3 Phase circuit to trip while allowing the remaining "leg" to remain energized. Generally accepted electrical safety standards require that 3 Phase type circuits be protected with listed breakers and that the breakers terminate power to all legs should an overload, fault, etc occur. I recommend that a qualified electrician evaluate and service as necessary.

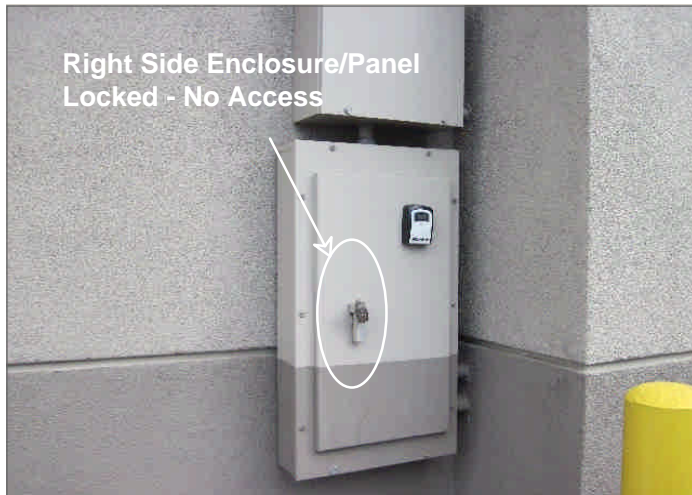
- 5.62 - There is an unlabeled panel at the right side area. The enclosure was locked and I was unable to access the interior or determine the area controlled/purpose. Interested parties should inquire of the sellers/occupants as to the purpose.

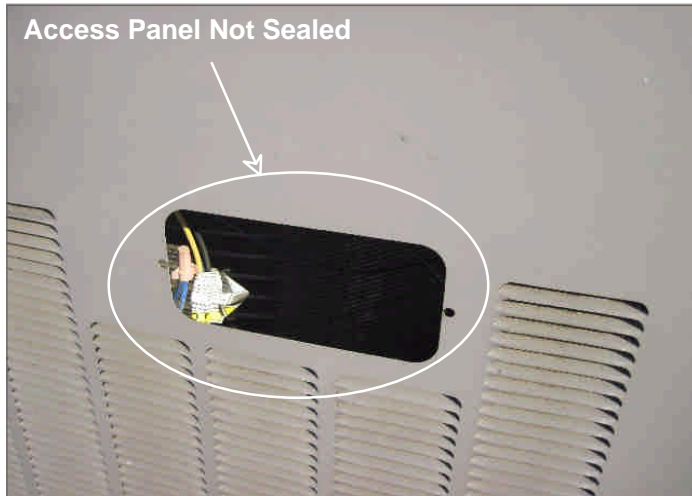
- 6.78 - NOTE: I suggest that the systems be clearly labeled as to the unit or area served so that the appropriate unit may be shut down in an emergency or by service personnel.
- Components & Conditions Needing Service/Evaluation*
- 6.79 - The Unit 130 system case/enclosure has an unsealed opening on the exterior case. It is recommended that a qualified HVAC contractor for further evaluate and service as needed.

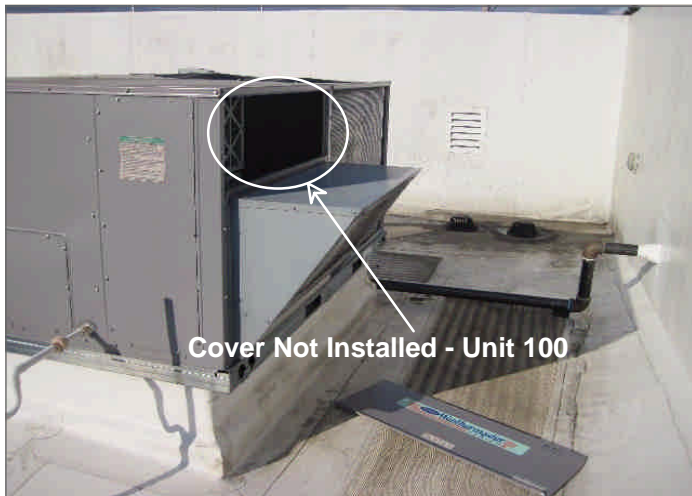
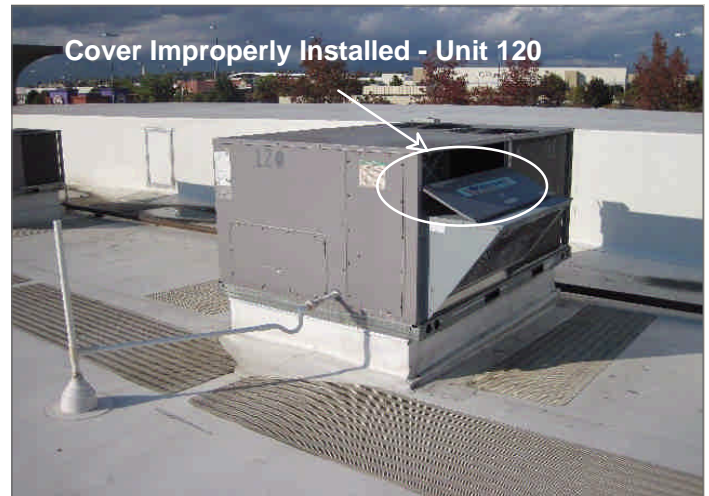
Two return air compartments are improperly sealed and should be serviced - Unit 100A & 120 - *Continued*

- 6.82 - Two return air compartments are improperly sealed systems Unit 100A & Unit 120. This condition reduces system efficiency. I recommend that a qualified HVAC contractor evaluate the system and service as necessary to ensure the proper and efficient operation of the installation.

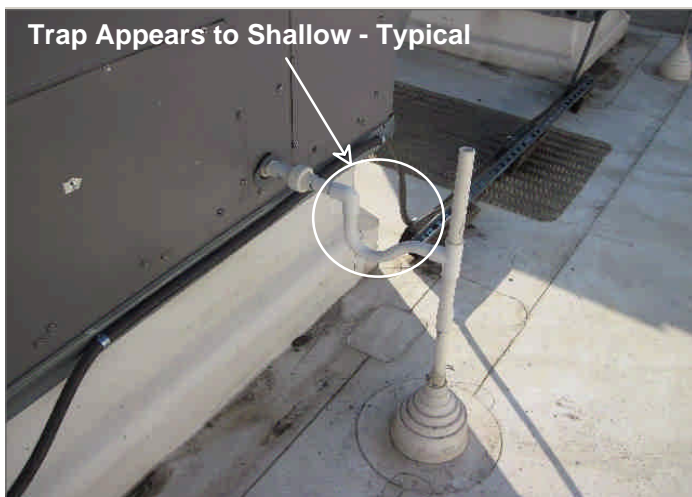
- 6.86 - The condensate drain trap is undersized for these units. In general, the trap should be at least 4" deep to prevent a loss of the trap/water seal due to air pressure. I recommend that this be evaluated and serviced as necessary by a qualified HVAC contractor.

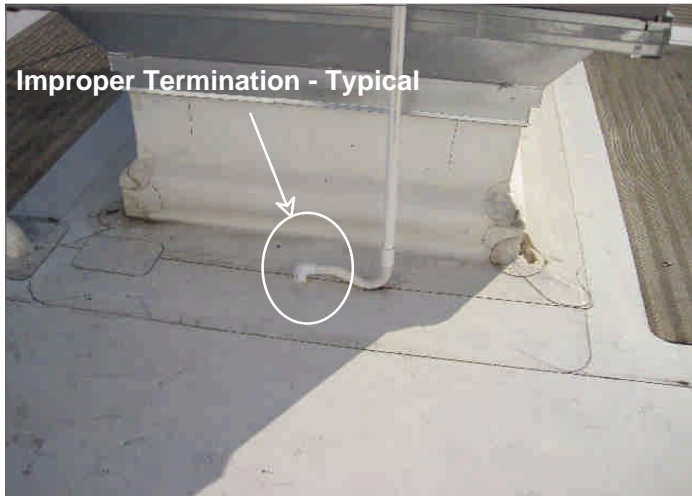
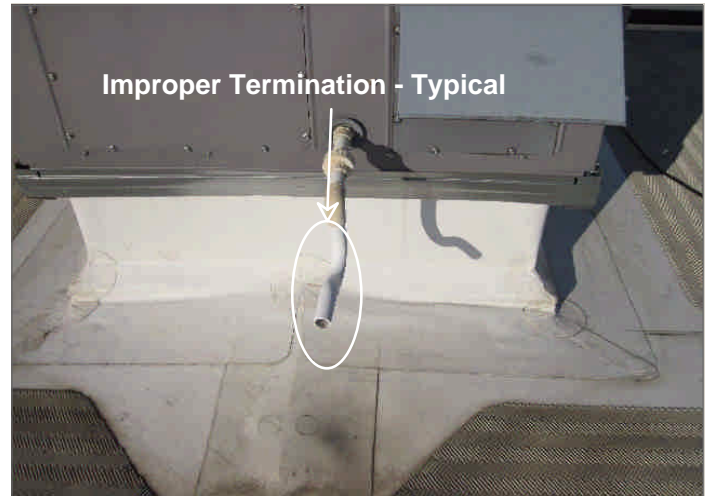
- 6.87 - A number of the unit condensate drain lines are improperly terminated on the roof - Units 130, 150, 160A 160B. It is recommended that a qualified HVAC contractor evaluate and service extend the

drain termination point to an approved location.

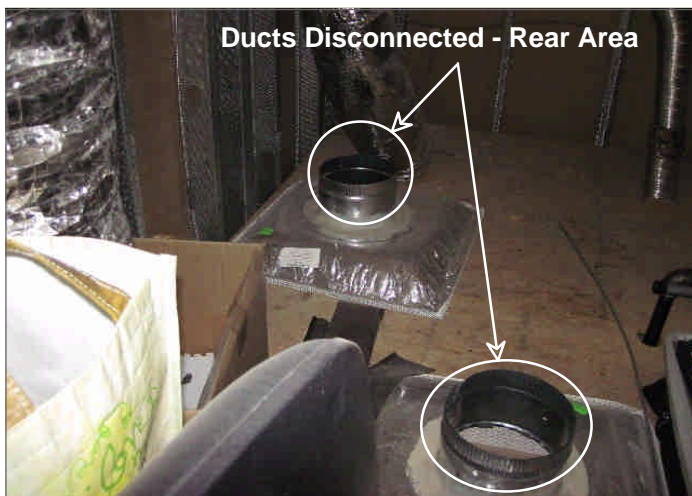
- q 6.92 - Several of the air distribution ducts are improperly connected and or separated in the rear ceiling area above Unit 130. I recommend that a qualified HVAC contractor evaluate and service/reconnect/secure as necessary.

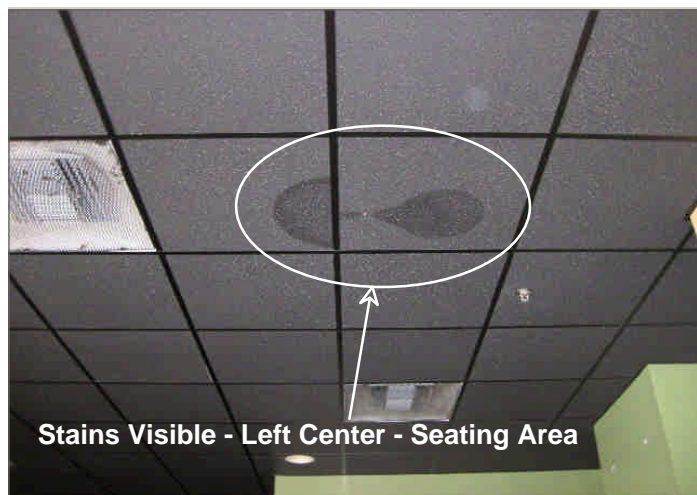
- q 7.13 - There are stains and or indications of prior moisture at the front left ceiling that should be further explained or the condition should be further evaluated by a qualified general contractor. I recommend consulting with the occupants/sellers as they generally have the most intimate knowledge of the property history and such issues. Interested parties should consult with a qualified general/roofing contractor for further information and or evaluation.

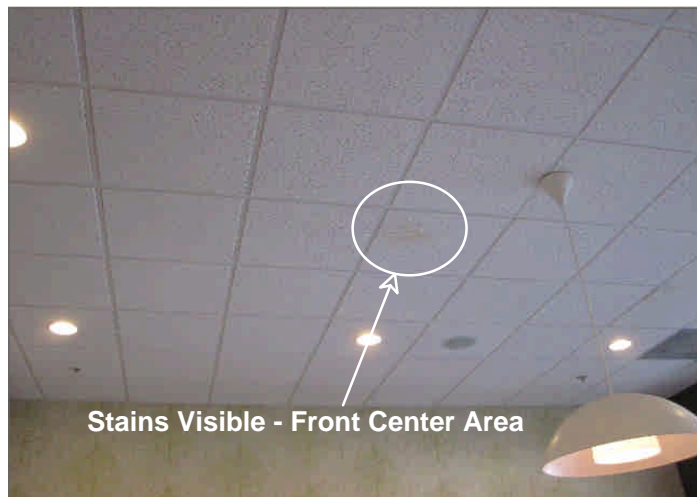
- q 7.60 - There are stains and or indications of prior moisture at the ceiling that should be further explained or the condition should be further evaluated. This area is roughly below the Unit HVAC system. I recommend consulting with the occupants/sellers as they generally have the most intimate knowledge of the property history and such issues. Interested parties may wish to consult with a by a qualified HVAC/roofing contractor for further information and or evaluation.

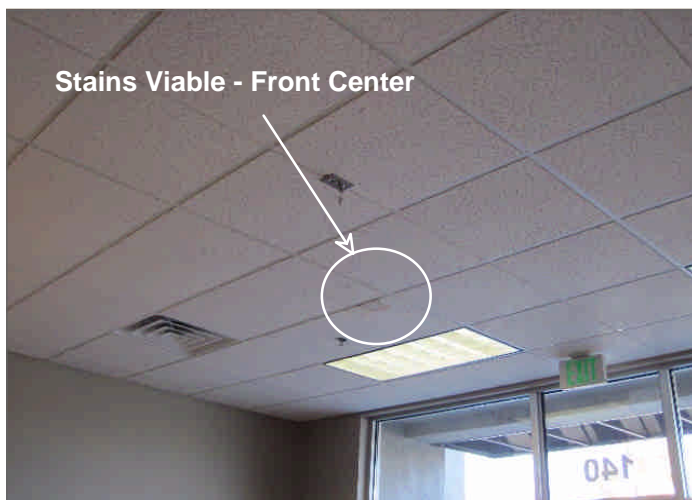
q 7.77 - There are stains and or indications of prior moisture at the ceiling that should be further explained or the condition should be further evaluated. This area is roughly below the Unit HVAC system. I recommend consulting with the occupants/sellers as they generally have the most intimate knowledge of the property history and such issues. Interested parties may wish to consult with a by a qualified HVAC/roofing contractor for further information and or evaluation.
