STUDY REPORT

SR 241 (2011)

Corrosion of Fasteners in Treated Timber

BRANZ Study Report SR 241

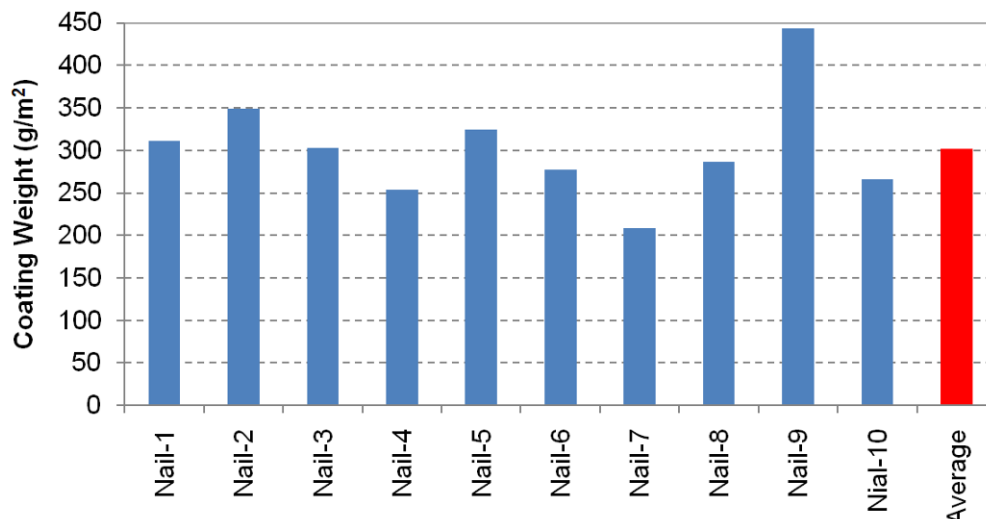
variation, ranging from 208 to 444 g/m². A comparison between this measurement and AS/NZS 4680 showed that the coating thickness on these nails could meet the requirements for articles that are centrifuged but not for the requirements for articles that are not centrifuged.

Figure 4: Average thickness of the zinc coating on the hot dip galvanised nails used in this study

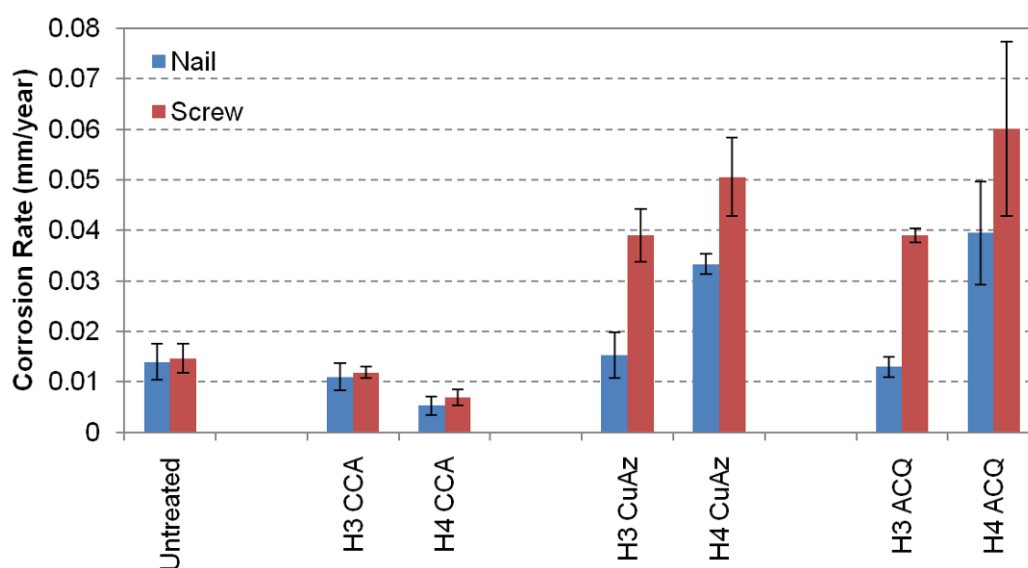
In general, fasteners exhibited a relatively low corrosion rate when embedded into CCA treated timbers, and this is consistent with the surface morphological observations. It is also interesting to note that the mass losses of the fasteners embedded in CCA (H3.2 and H4) treated timbers do not differ greatly from those of the fasteners embedded in untreated timbers. CuAz and ACQ treatments promoted markedly increased corrosion rates. For example, the mild steel nails had a corrosion rate of 6.63×10^{-2} mm/year in H4 ACQ treated timber, while equivalent corrosion rates in H4 CCA and untreated timbers were 1.87×10^{-2} mm/year and 2.66×10^{-2} mm/year, respectively. In addition, an increase of the copper content in the preservation chemicals appeared to increase the aggressivity of the treated timber towards metal. This measurement result also agrees with the morphological characterisation where heavier corrosion products (zinc-rich and/or iron-rich rusts) covered larger surface areas.

Figure 13: Corrosion rates of mild steel fasteners embedded into timbers exposed at Judgeford site for one year

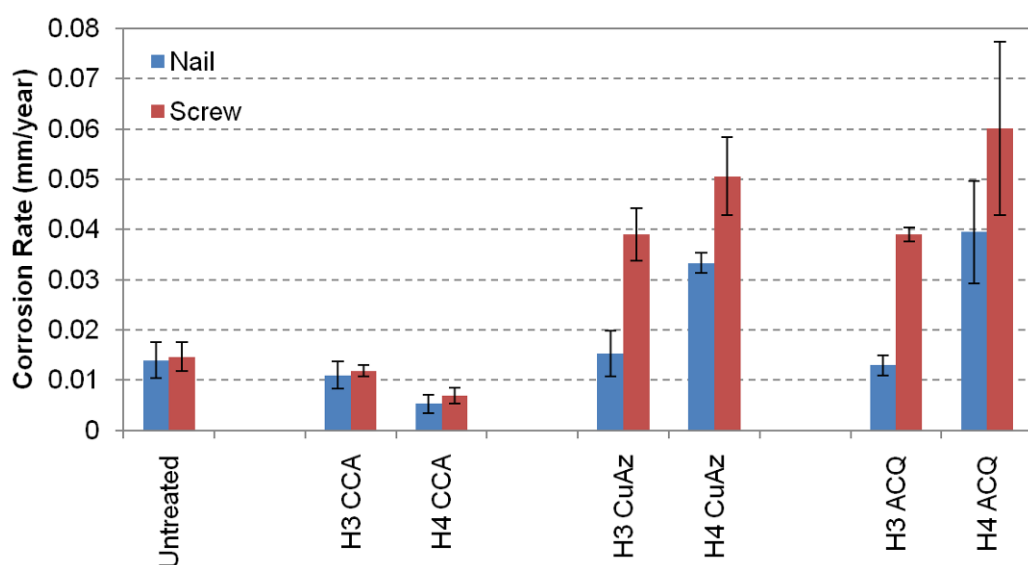
Figure 14: Corrosion rates of zinc-coated fasteners embedded into timbers exposed at Judgeford site for one year

Zinc coatings provided enhanced protection to the steel substrates, reflected in lower mass losses, particularly with hot dip galvanised nails. However as observed from the morphological observations, the coating in the thread area of screws was prone to damage during the driving-in process. Thus, a mechanically applied zinc coating cannot always be anticipated to provide long-term protection from corrosion.

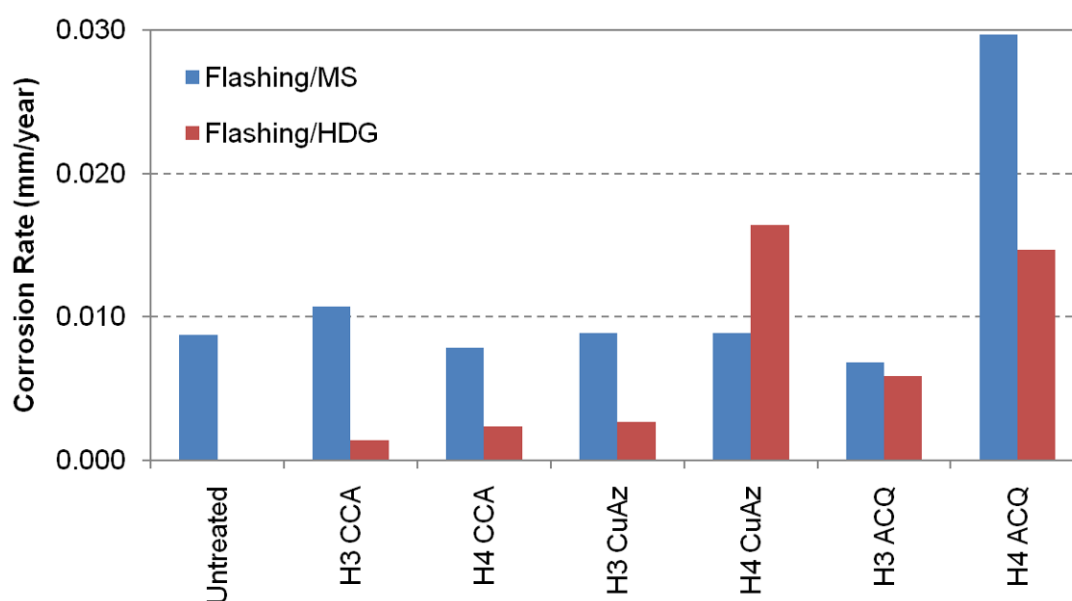
The corrosion rates of the mild steel flashings in contact with different timbers were generally very similar (Figure 15). The only exception was that the flashing attached to the H4 ACQ treated timber showed a much higher mass loss, 2.97×10^{-2} mm/year, which is three to four times higher than the others.

Figure 15: Corrosion rate of flashings in contact with timbers exposed at Judgeford site for one year. Note that corrosion rate of galvanised steel flashing in untreated timber is omitted and results are from single specimens so an estimate of uncertainty is impossible (MS: Mild Steel; HDG: Hot Dip Galvanising)

In the case of the hot dip galvanised steel flashings, it is readily apparent that contact with timbers treated with ACQ or CuAz resulted in a higher corrosion rate than contact with CCA or untreated timbers. Furthermore, an increase of the hazard class from H3.2 to H4 also increased the corrosion rate. This result is consistent with the morphological observations.

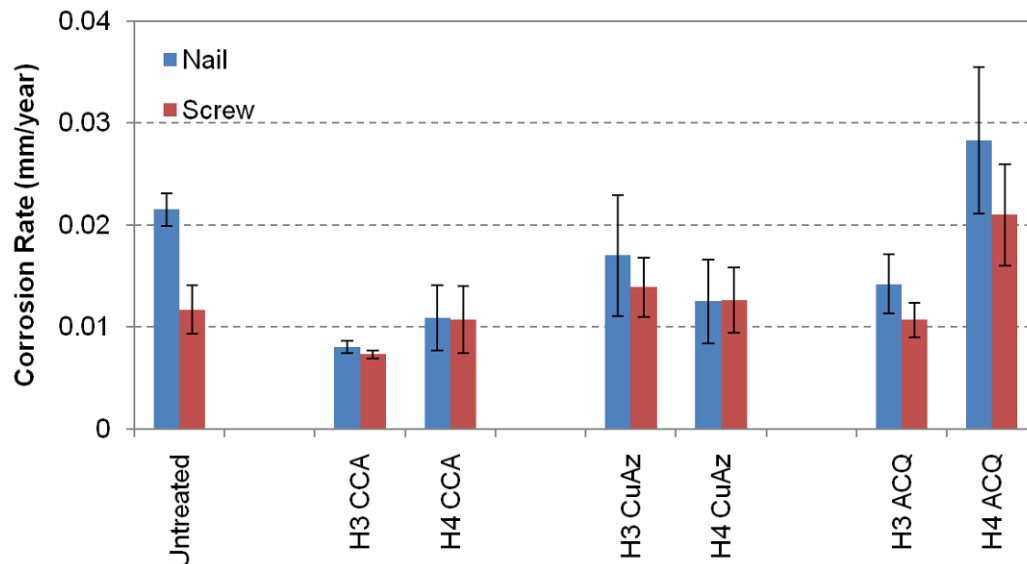
Measurements showed that the corrosion rates of the mild steel nails and screws inserted into the untreated timbers were higher than those of the nails and screws inserted into H3 and H4 CCA treated timbers. H4 ACQ treated timbers were the most corrosive. Metal corrosion in H3 ACQ, H3 CuAz and H4 CuAz treated timbers was not significantly accelerated in comparison with that in H3 and H4 CCA treated timbers under identical testing conditions (Figure 19). This observation is somewhat different from the results obtained after one year of exposure.

Figure 19: Corrosion rates of mild steel fasteners embedded into timbers exposed at Judgeford site for two years (these fasteners were inserted into the timber blocks fixed at the lower (side) part of the gate structure and their longitudinal orientation was parallel to the ground)

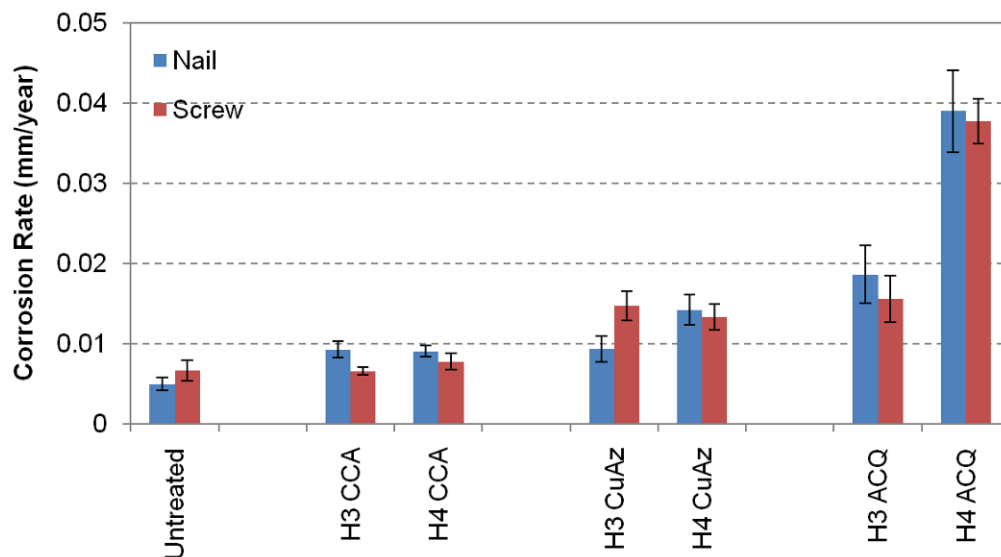
Zinc-coated fasteners in CuAz and ACQ treated timbers were losing their coatings at a higher rate than those in untreated and CCA treated timbers and this trend was particularly obvious for screws. Again, H4 ACQ treated timbers exhibited the highest aggressivity towards metallic fasteners. The mass loss rate of metal in this timber could be two to four times higher than that of metal in CCA and CuAz treated timbers (Figure 20).

Figure 20: Corrosion rates of zinc-coated fasteners embedded into timbers exposed at Judgeford site for two years (these fasteners were inserted into the timber blocks fixed at the lower (side) part of the gate structure and their longitudinal orientation was parallel to the ground)

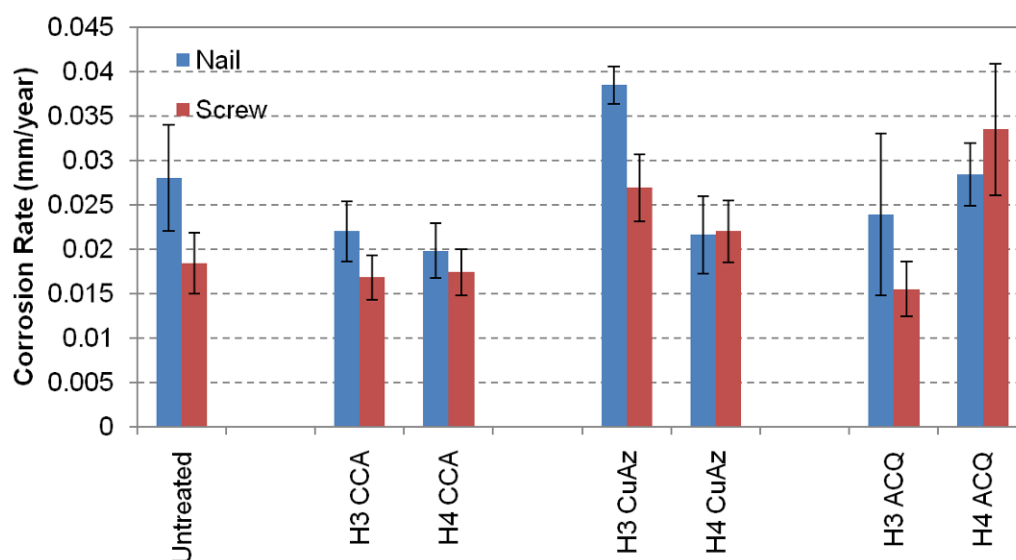
Average corrosion rates measured for the mild steel fasteners retrieved from the top part of the gate-shaped timber structures after three years of exposure at the Judgeford site showed that the degradation behaviours of these fasteners in timbers of different preservation treatments were somewhat similar (Figure 30).

Figure 30: Corrosion rates of mild steel fasteners embedded into timbers exposed at Judgeford site for three years (these fasteners were retrieved from the top part of the gate-shaped timber structure i.e. their longitudinal orientation was vertical to the ground)

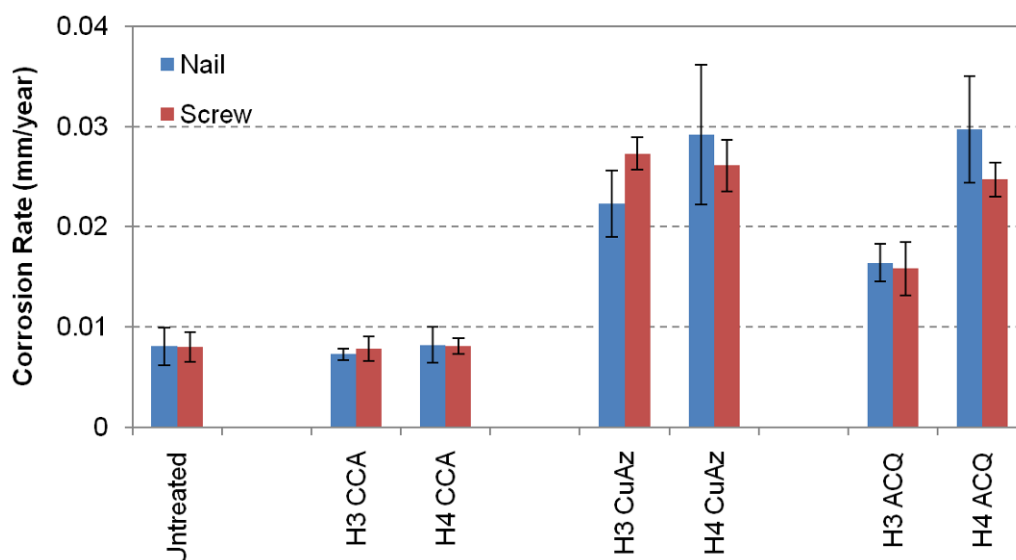
Figure 31: Corrosion rates of zinc-coated fasteners embedded into timbers exposed at Judgeford site for three years (these fasteners were retrieved from the top part of the gate-shaped timber structure i.e. their longitudinal orientation was vertical to the ground)

Hot dip galvanised nails and mechanically-plated screws performed slightly better than their mild steel counterparts, particularly in untreated and CCA treated timbers. This might be due to the cathodic protection of the zinc coating (Figure 31). When inserted into either CuAz or ACQ treated timbers, these fasteners still exhibited high corrosion rates, similar to the levels measured with mild steel fasteners. H4 ACQ treatment was found to be 3.6 times as corrosive as H4 CCA treatment. This corrosion acceleration factor is much larger than that observed with mild steel components. This finding from mass loss measurements was fully supported by surface morphological characterisations; most of the zinc coating was consumed and extensive red iron-rich rust was developed. This result again showed that CuAz and ACQ treated timbers exhibited a much higher aggressivity towards zinc-coated components than untreated and CCA treated timbers under identical exposure conditions.

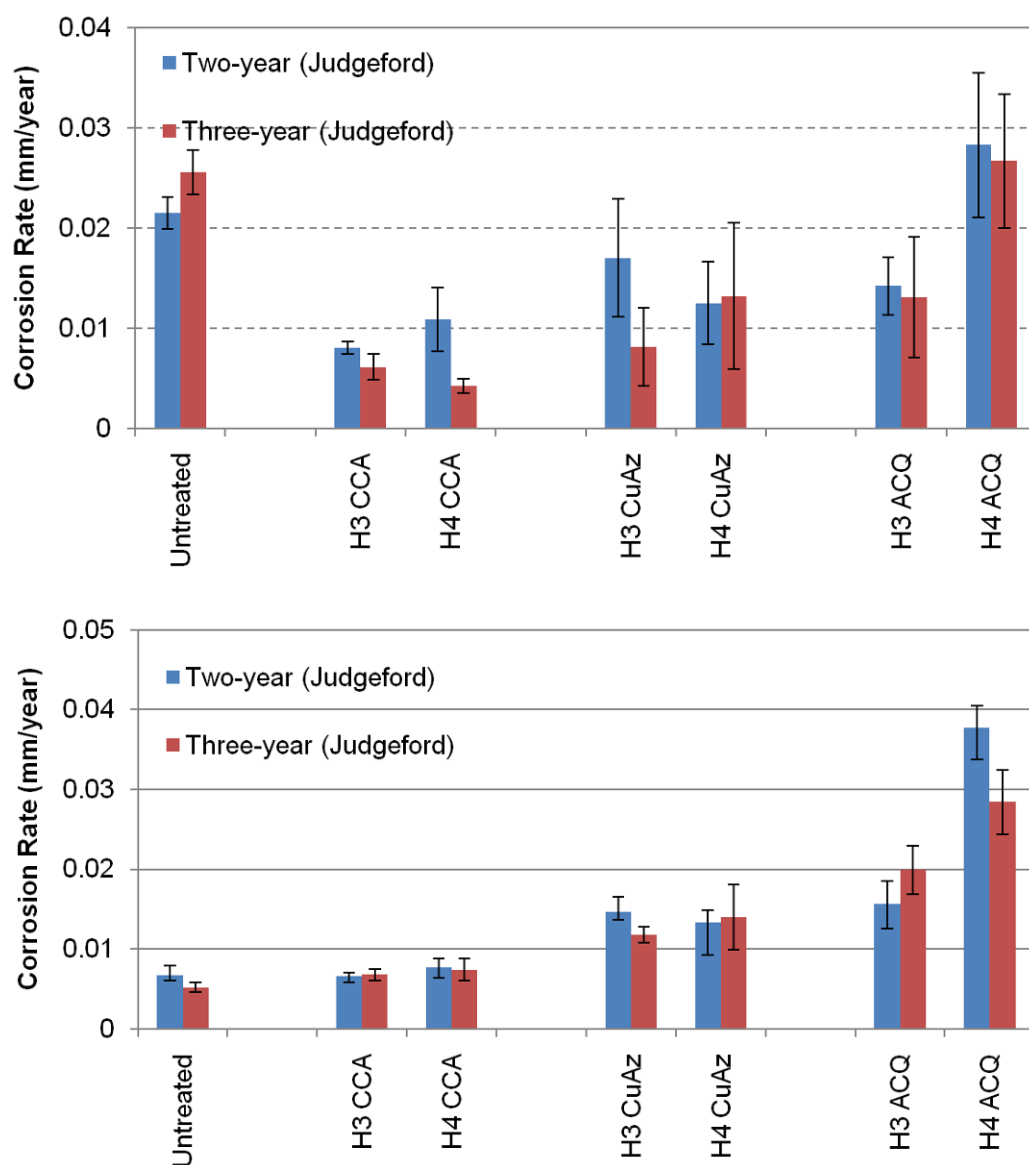
Measurements with fasteners inserted into the side part of the gate-shaped timber structures generally showed that the averaged two-year and three-year corrosion rates were not quite different in all these timbers. The exceptions were mild steel nails inserted into H4 CCA and H3 CuAz treated timbers and mechanically-plated screws in

H4 ACQ treated timbers (Figure 43). These results also indicated that the corrosion rate of metal in CCA treated timbers was not changing markedly within the timeframe of this field exposure test.

Figure 43: Corrosion rates of mild steel nails (top) and mechanically-plated screws (bottom) measured after two-year and three-year exposures at Judgeford site (these fasteners were retrieved from the lower (side) part of the gate-shaped timber structure i.e. their longitudinal orientation was parallel to the ground)

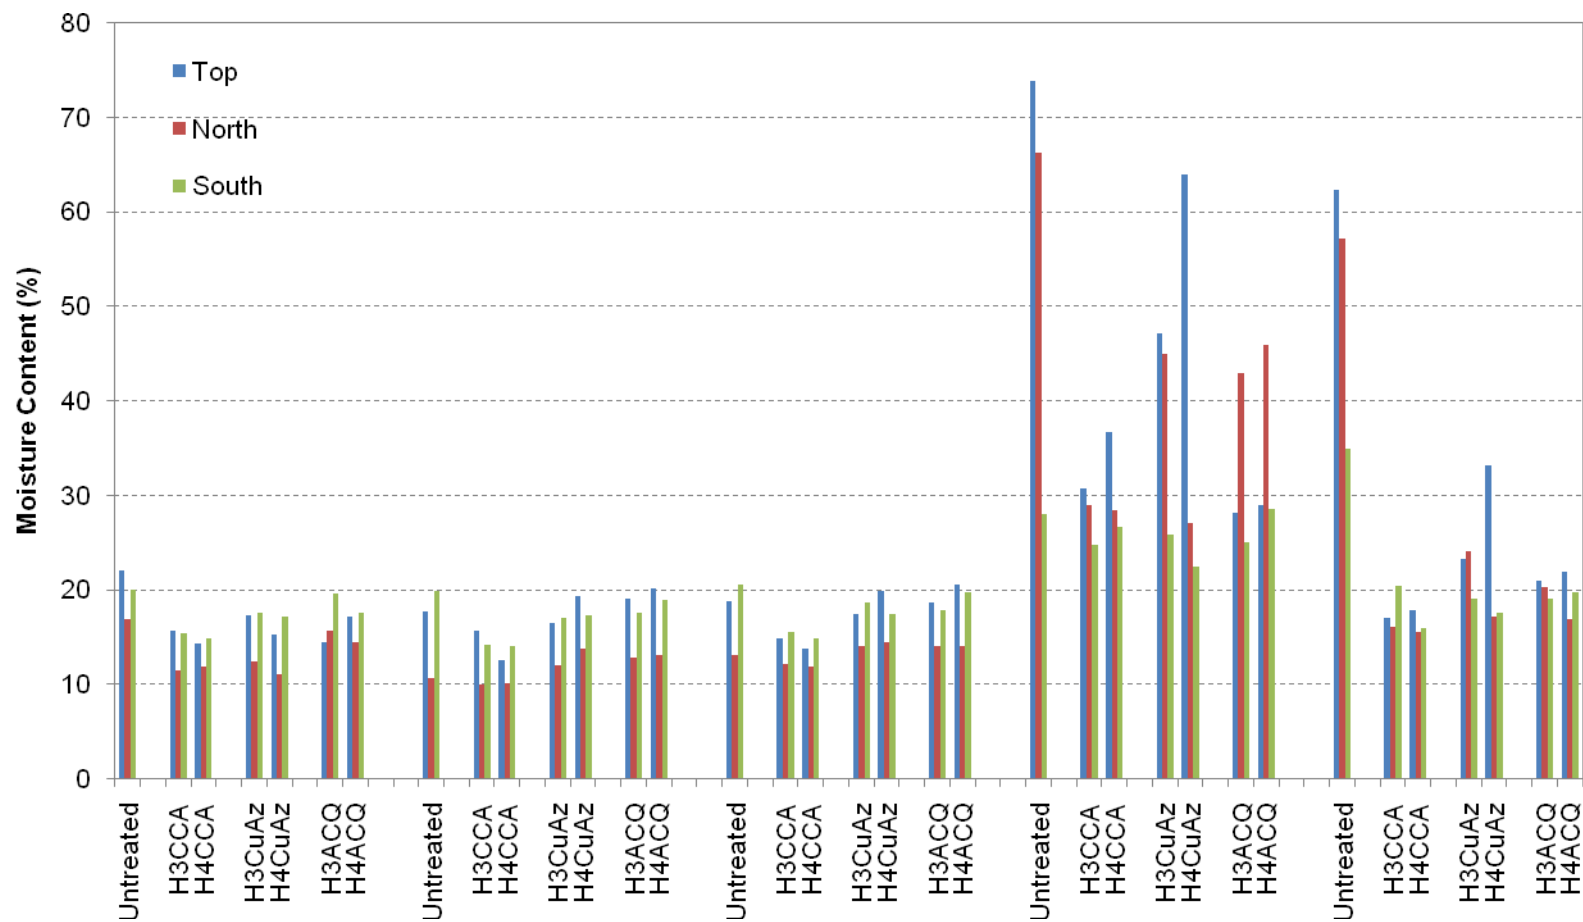
From Figures 45 and 46, it can be seen that the timber blocks at the top of the gate had a higher moisture content than the blocks at the side. In addition, the south side is generally wetter than the north side. This might be a result of different times of heating by solar irradiation. Actually, the surface temperature of the timber on the south side was measured to be about 2°C lower than that on the north side.

Figure 45: Moisture content of timber blocks exposed at Judgeford site – the date for test is (from left to right): 01/April, 12/April, 13/April, 14/April and 15/April/2010

Figure 46: Moisture content of timber blocks exposed at Judgeford site – the date for test is (from left to right): 01/July, 05/July and 14/July/2010

In addition, measurements shown in Figures 45 and 46 imply that CuAz and ACQ treated timbers tend to have slightly higher moisture content than CCA treatment, although the mechanism behind this is not known (and the results need to be confirmed).

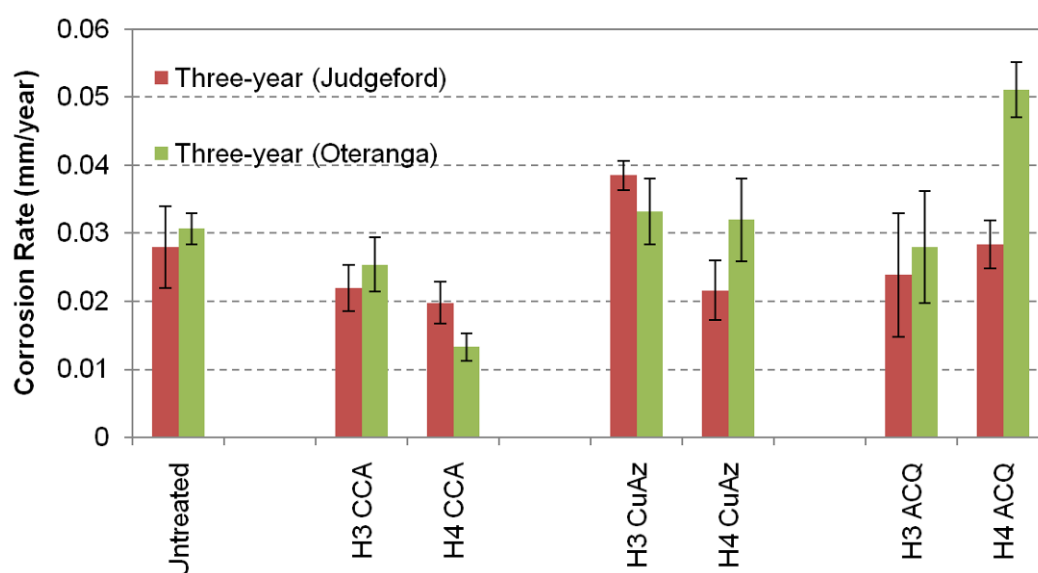
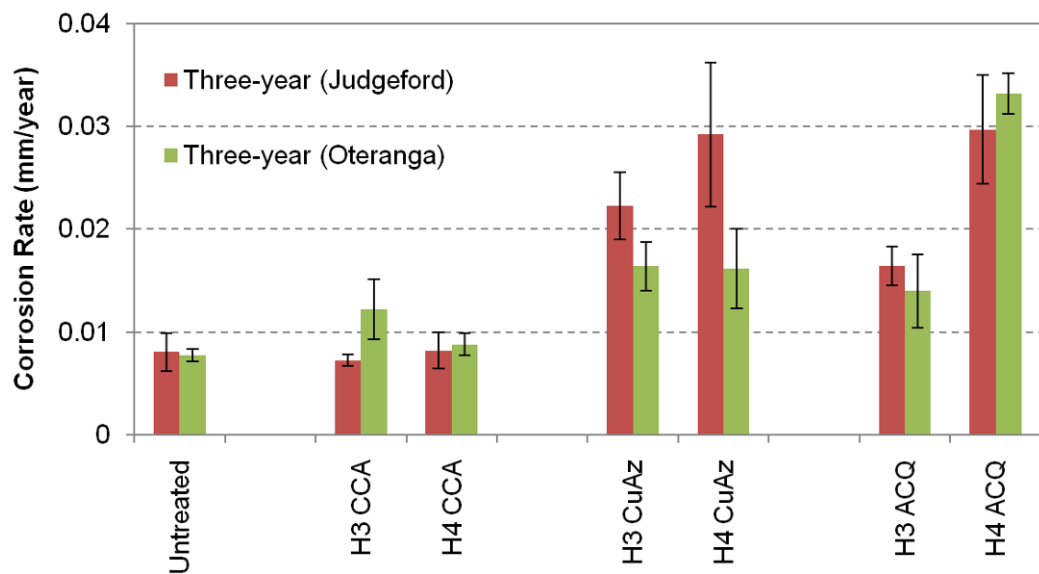
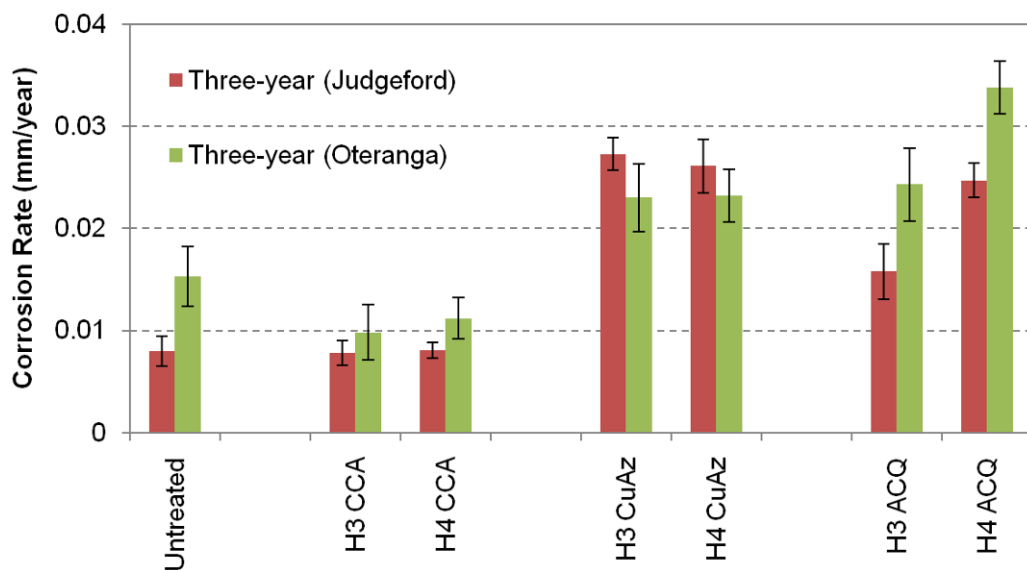
A comparison between the corrosion rates and surface morphologies of the fasteners embedded into the timbers exposed at these two sites showed that the macro-environment was affecting the corrosion process. Mild steel fasteners (including nails and screws) and mechanically-plated screws inserted into the timbers exposed at Oteranga Bay generally had a slightly higher corrosion rate than those inserted into the timbers exposed at Judgeford. However, corrosion rates measured with the hot dip galvanised nails exposed at Oteranga Bay were not always higher than those at Judgeford. Actually, lower corrosion rates were even observed with galvanised nails inserted into H3 and H4 CuAz treated timbers exposed at Oteranga Bay. Those were 56-74% of the rates obtained from the Judgeford site (see Figures 47 through 49).

Mild steel has very low resistance to corrosion. Its mass loss in a severe marine environment (i.e. Oteranga Bay) could be at least two to four times greater than that in a moderate environment (i.e. Judgeford). Mild steel fasteners would then experience a faster corrosion on their head areas, contributing to a slightly higher corrosion rate when averaged by the whole surface area. This agrees well with the current measurement results.

Figure 47: Corrosion rates of mild steel nails measured after three years of exposure at Judgeford and Oteranga Bay

Figure 48: Corrosion rates of hot dip galvanised nails measured after three years of exposure at Judgeford and Oteranga Bay

Figure 49: Corrosion rates of mechanically-plated screws measured after three years of exposure at Judgeford and Oteranga Bay

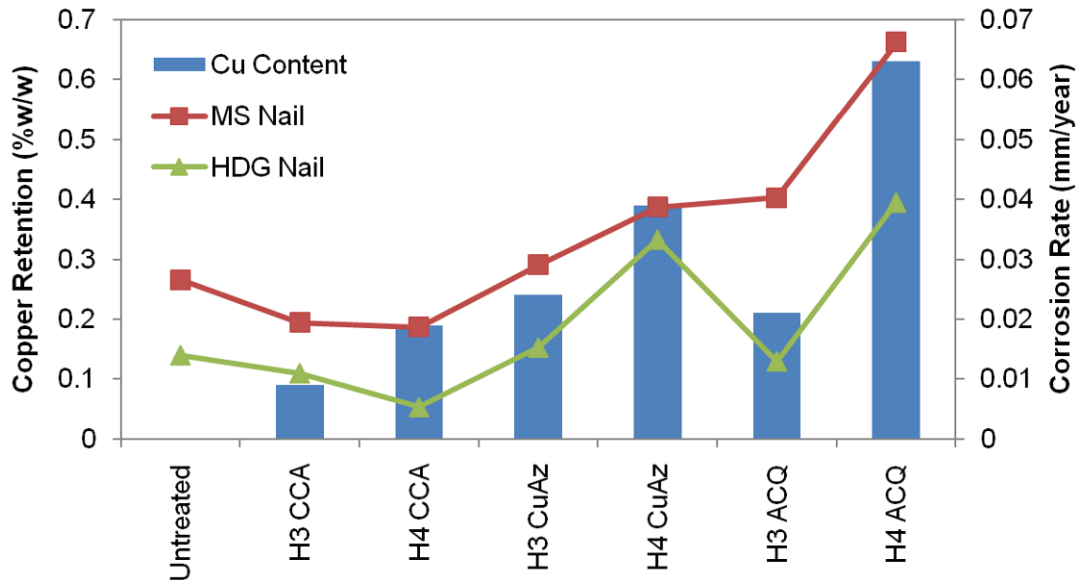
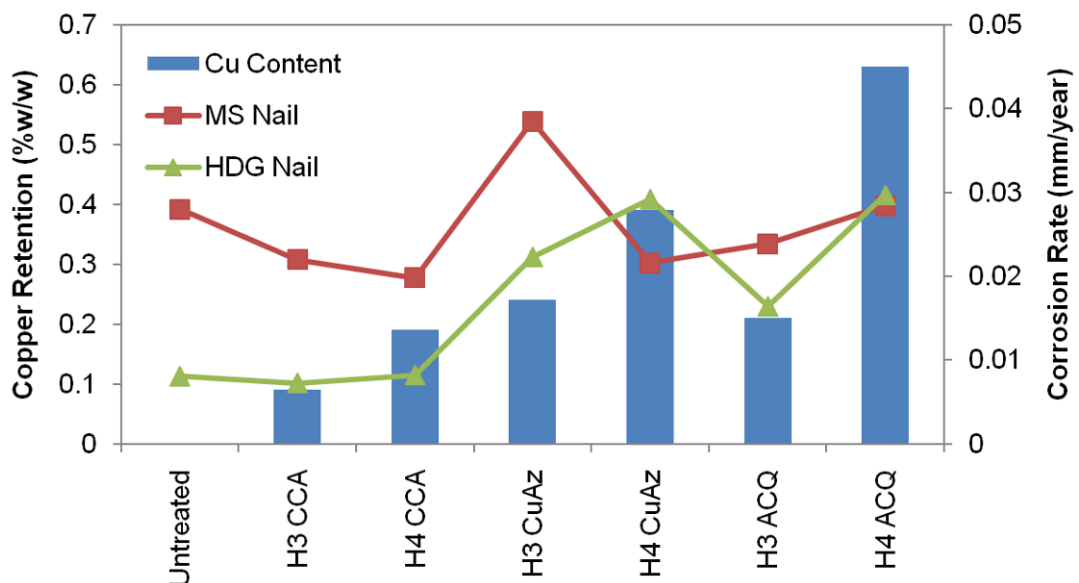
Figures 50, 51 and 52 present the correlation between the retained copper content in the freshly treated timber and the experimentally measured corrosion rate of mild steel and hot dip galvanised nails in this study.

- The corrosion rates in H3 and H4 CCA treated timbers are approximately equal (or even lower in H4 CCA treatment) despite the retained copper concentration in H4 being virtually double that in the H3.2 grade.
- The copper content in H4 ACQ treated timber is about 3.3 times as high as the content in H4 CCA treated timber. However the corrosion rate in H4 ACQ treated timber is 3.5 and 7.4 times higher than the rate in H4 CCA treated timber for mild steel and galvanised steel fasteners, respectively.

- The copper content in H4 ACQ treated timber is three times as high as the content in H3 ACQ treated timber. However the corrosion rates in H4 ACQ treated timber are only about 1.2-1.8 and 1.8-3.0 times higher than the rates in H3 ACQ treated timber for mild steel and galvanised steel fasteners, respectively.

Figure 50: Correlation between copper retention in the freshly treated timbers and corrosion rate of nails embedded in the timbers exposed at Judgeford site for one year

Figure 51: Correlation between copper retention in the freshly treated timbers and corrosion rate of nails embedded in the timbers exposed at Judgeford site for three years

Figure 52: Correlation between copper retention in the freshly treated timbers and corrosion rate of nails embedded in the timbers exposed at Oteranga Bay for three years

These observations indicate that copper retention has a degree of correlation with the corrosion performance of metallic building hardware embedded into treated timbers. However this correlation might only be valid for short testing periods. In extended exposure, the effective copper ions involved in metal corrosion processes would tend to deviate from the original copper retention due to:
